Y-TYPE NEWSLETTER

Off with its head!

The Henderson family turn potential disaster into absolute triumph. By Sandy Henderson

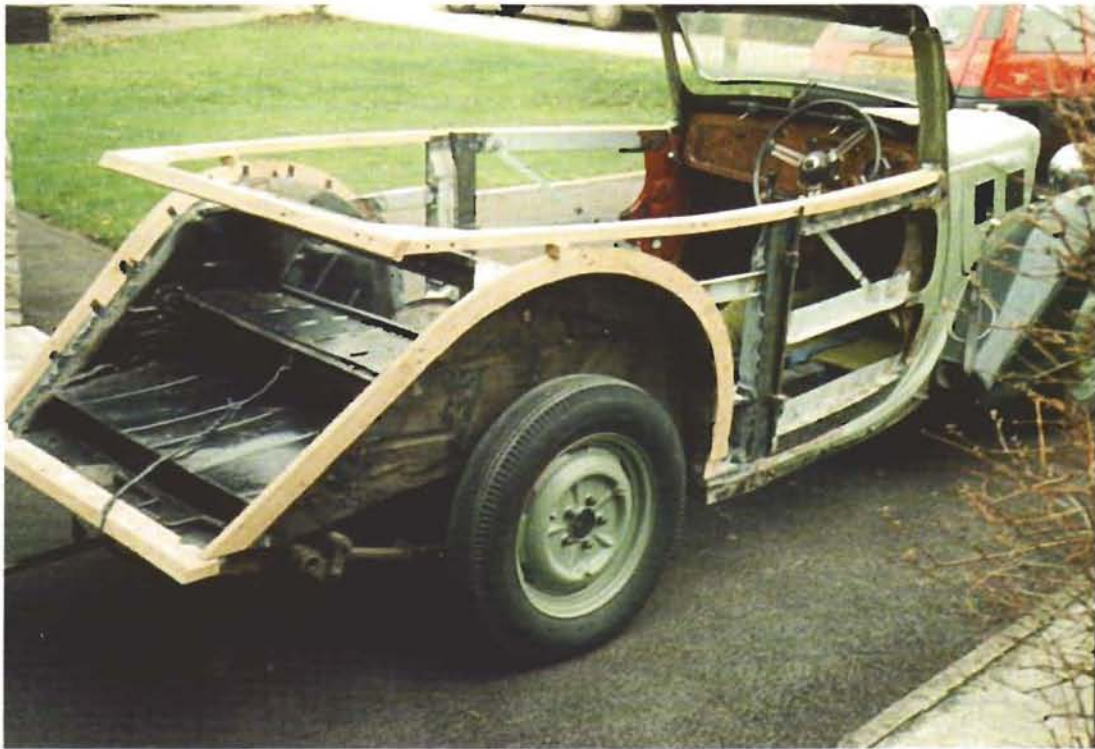
Below: Door tops now finished two inches lower than they had on the saloon.

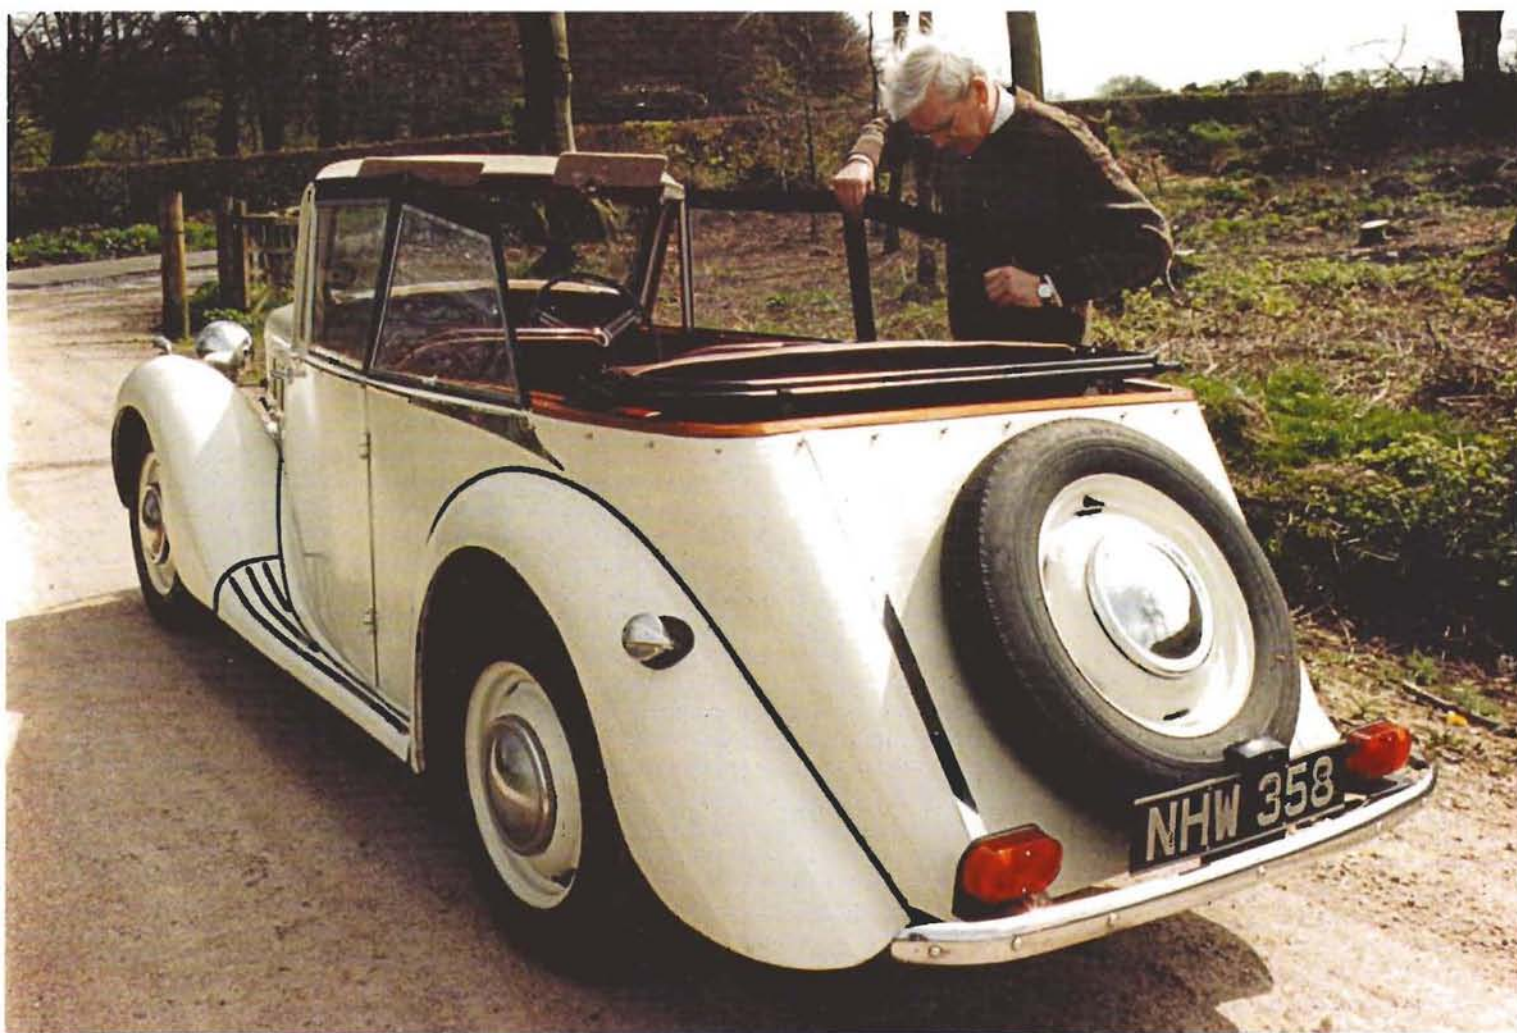
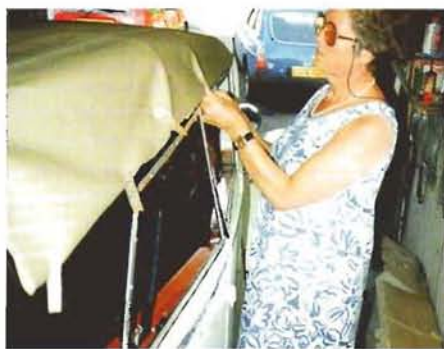
Above and left: Bringing the crumpled Y back to life was very much a family affair for the Henderson household.
