# REBUILD STORY- **MG YA**

Originally printed in The Bulletin, September 2013. The Bulletin is the official magazine of the MG Octagon Car Club. You can join the MG Octagon Car Club at [www.mgoctagoncarclub.com](http://www.mgoctagoncarclub.com)

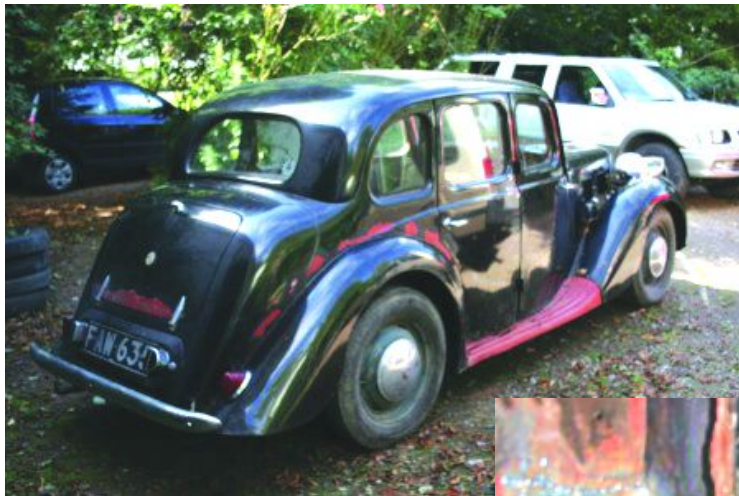
*The YA as originally viewed in August*

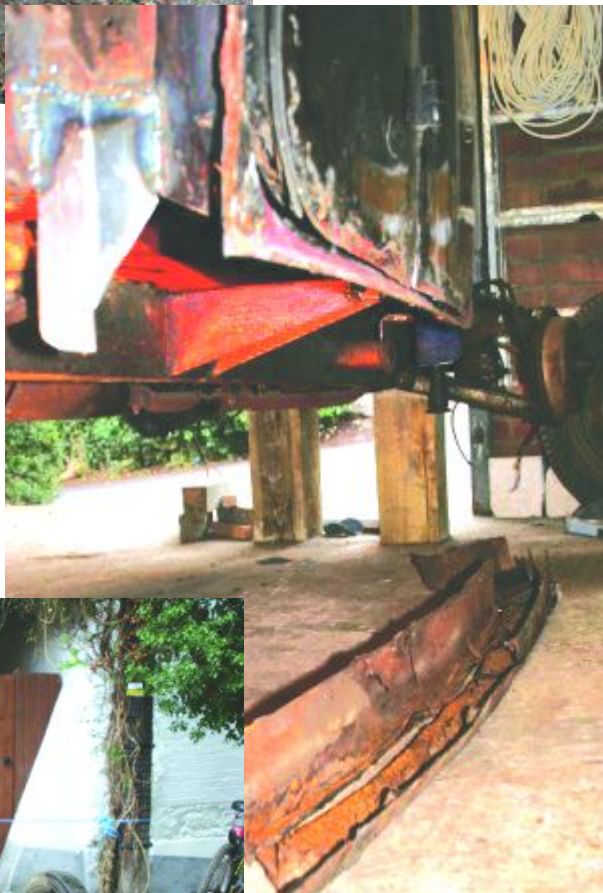
On closer examination the rust spots on the sills were not spots but big holes covered with pop riveted bits of old metal and filler. In fact the sills disintegrated leaving only a one inch strip of original car underneath the door. It got worst as I investigated the boot floor. What appeared to be sound metal was pop riveted aluminium strips covered with bitumastic paint. The inner rear wheel arches were also held on by pop rivets and odd pieces of steel. The body had actually collapsed on to the chassis.

*Not much metal was left! The old sill on the floor was only held on with pop rivets and body filler. On its way to the paint shop*

First, wings, doors and other detachable panels were sent away for sandblasting to reveal the full extent of the rust. Next, with the help of a neighbour the body was braced, the doors rehung so we had a reference point, and new sills, using replacement panels from NTG, welded in to hold the front and rear of the car together. The body was then jacked up and repair pieces fabricated and welded to the rear inner wings and, floor and boot floor. The chassis was sound with only the body support brackets requiring reinforcing.
