Readers' RESTORATIONS

'Basket case' MG

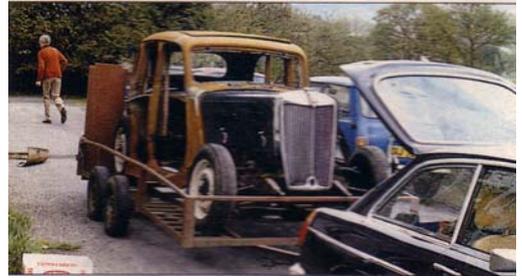
A sad looking MG Y-Type in need of restoration.

So the 'original basket case' was taken home and stripped completely. The chassis was in reasonable condition, merely having several holes around the rear spring hanger area, but the body was exceptionally bad and only just worth restoring. To make it worse, it seemed that everyone having owned the car, had tried to restore it and had lost essential bits and pieces between them. I sincerely envied fellow restorers who took every piece off themselves and labelled them ready for the rebuild. All I had was a box of goodness knows what.

The chassis was carefully blasted and the holes welded. It was given an undercoat of red oxide and a top coat of good quality paint and was supported on four axle stands. The

The front suspension was completely rebuilt, the radiator received a new core, the springs were taken down to the basics and everything was given a thorough clean. The rear axle was replaced, the propeller shaft was fitted with new universal joints and the clutch mechanism was overhauled.

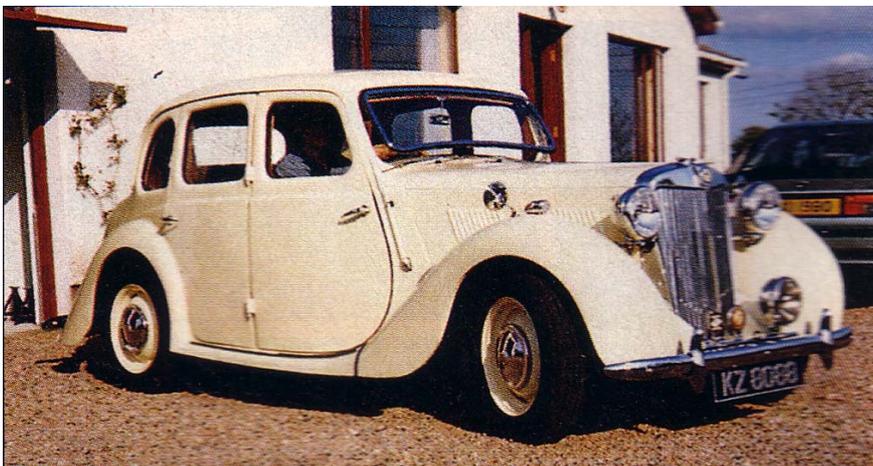
Worth the hassle and four years of dedication. Miles resisted the temptation to advertise the car as "an uncompleted restoration".
