Sealing the Sender Unit

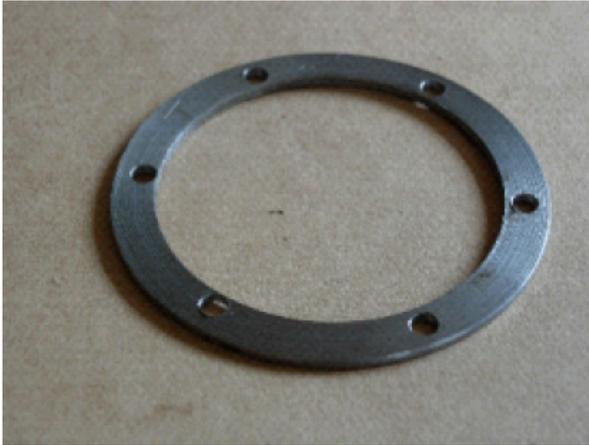
Faced with this problem I went back to first principles. Since the Mazak is weak, a strengthening steel ring was turned and drilled to fit over the flange. Carefully, the flange was flattened by gentle tapping with a hammer. Although most of the distortion was removed there was still considerable room for improvement as can be seen in the photograph. The solution

was to turn a flat surface using the lathe.

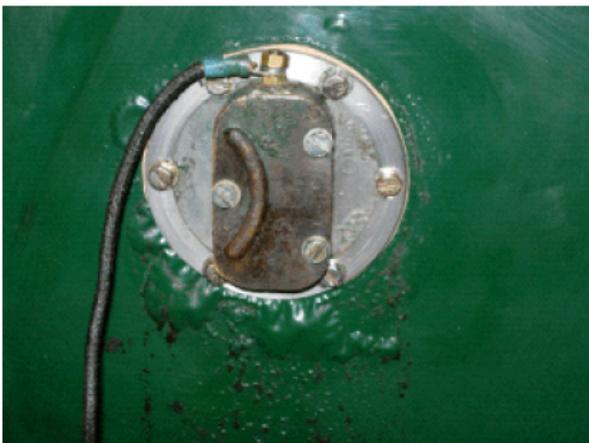
The bubbling of the paint is due to petrol previously having got under the two-pack paint. So far, – no leaks!
