GEARBOX MOUNT – REAR CASE Lonnie Cook, rev 26-Mar-2017

Mount on rear case of gearbox

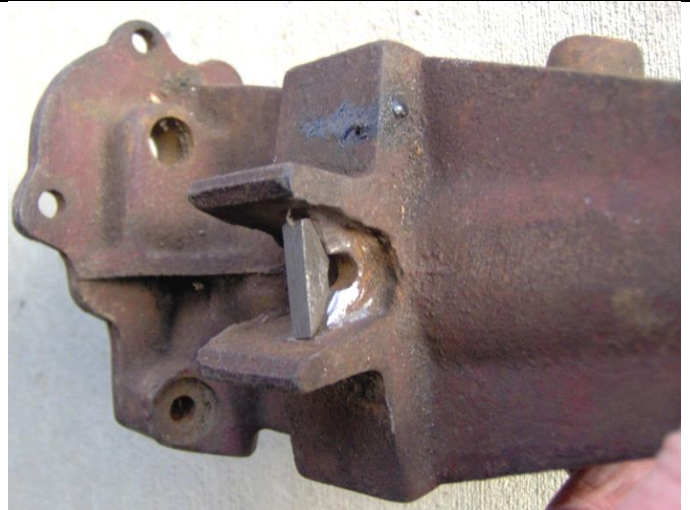
The "eye" in the mount on the rear case of the gearbox frequently breaks.

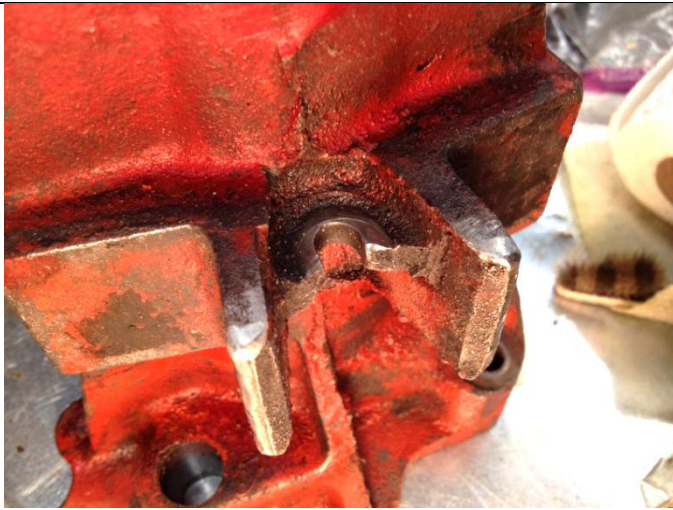
Broken mount – TF7211

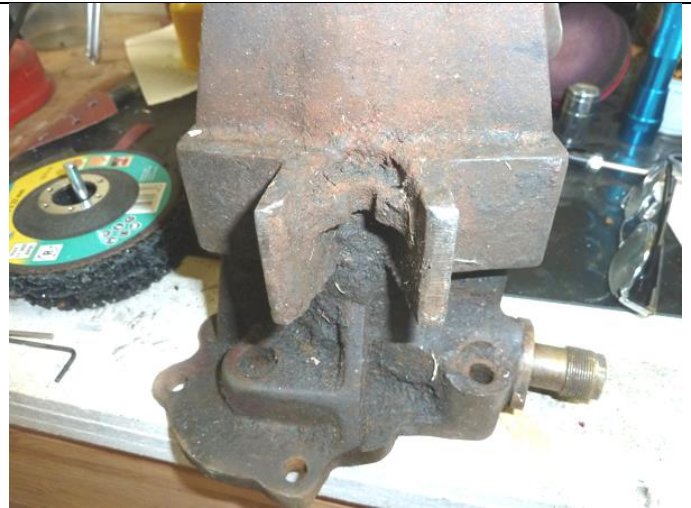
Broken mount before

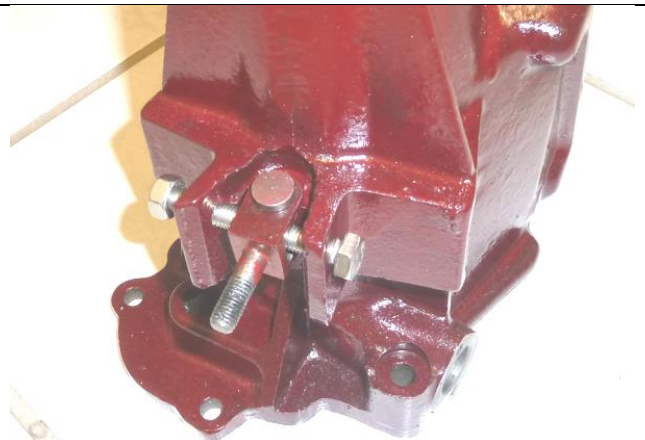
Broken mount after

The pin in the fork rests on top of the new bolt. This allows the engine and gearbox to rotate with torque as the original mount did. However, the gearbox can shift left and right slightly.

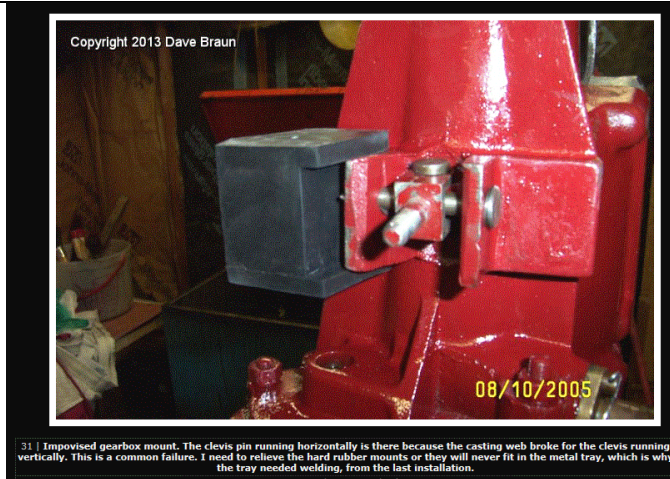
Improved gearbox mount. The clevis pin running horizontally is there because the casting web broke for the clevis running vertically. This is a common failure. I need to relieve the hard rubber mounts or they will never fit in the metal tray, which is why the tray needed welding from the last installation.

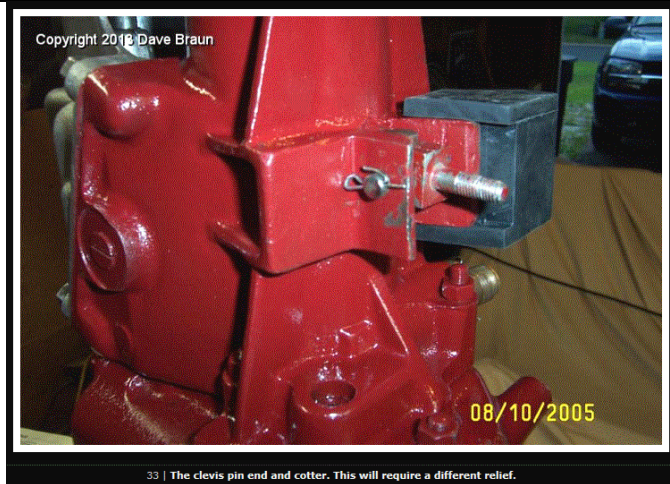
The clevis pin end and cotter. This will require a different relief.

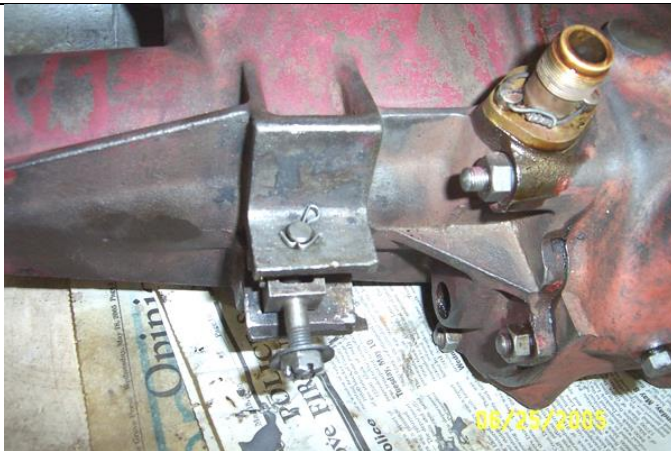
A similar repair with a clevis and split pin.

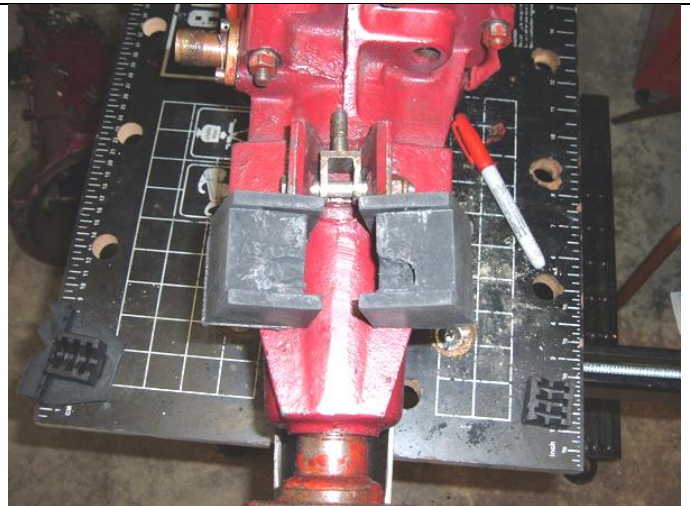
A different repair - The bolt goes through the holes in the fork and therefore does not allow the engine and gearbox to rotate. Causes strain on the gearbox case.

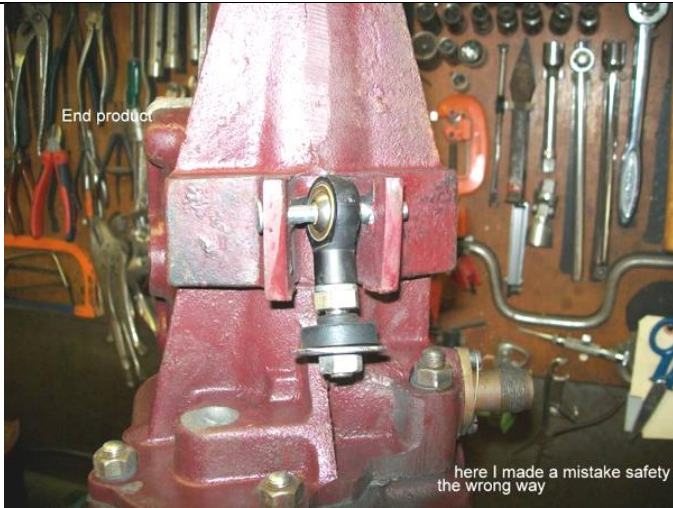
Another type of repair using a rose joint.

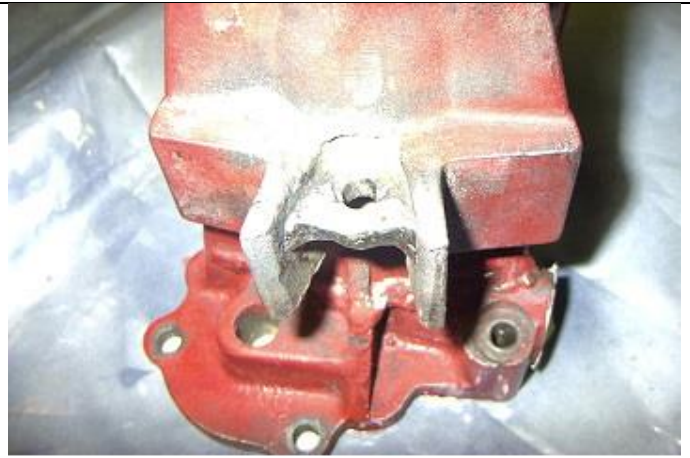
Weld repair

Grind off the edges of the rubber mount rubbers that contact the slightly rounded inside corners of the steel tray. Otherwise, the rubbers will not seat completely into the tray, which will prevent the threaded shaft of the fork from extending through the rubber rebound bumper to mate with the castle nut.
