# CARS WORTH KEEPING

## MG YB

His friends thought he was living up to his name when Philip Reckless bought the remains of this MG

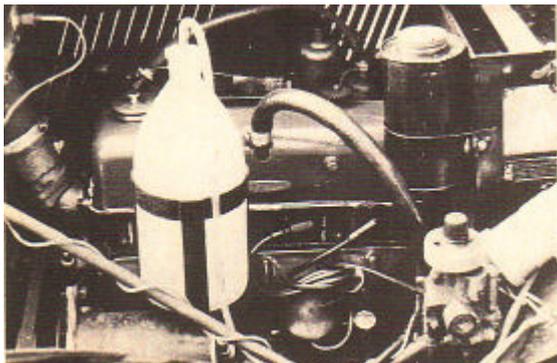
One advantage of older vehicles is that there is plenty of room to work — note the clear layout of the wiring
