## THE CLASSIC 'Y'

The Newsletter of the M.G. 'Y' Type Register.

Volume 9. No.75.

June 1986.

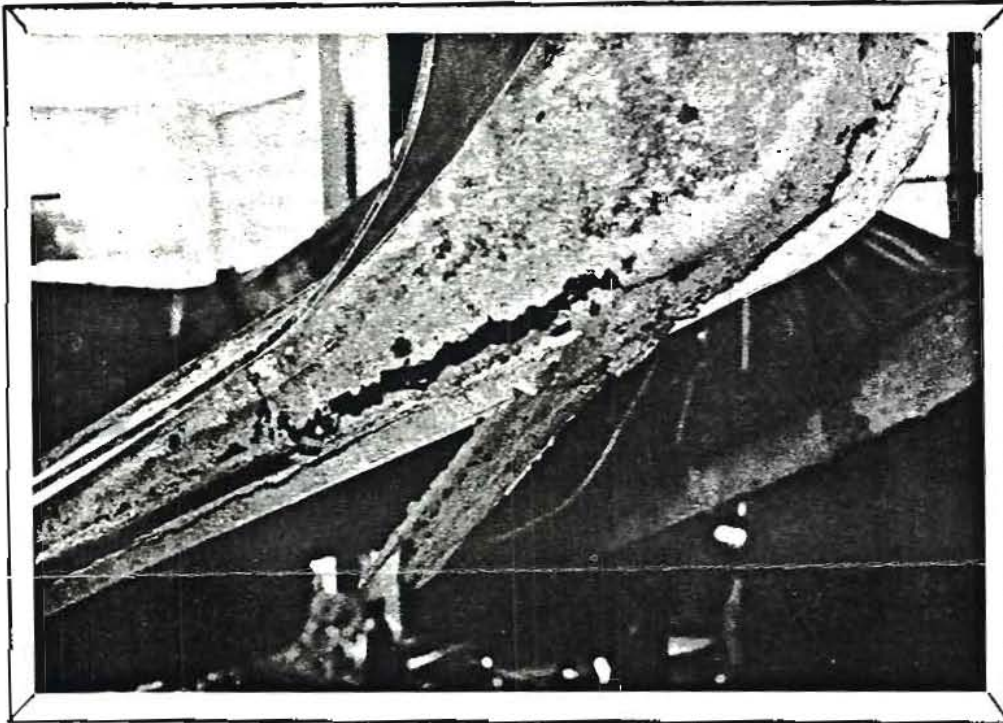
EXAMPLE OF RUST - SILLS

The chassis, body, guards etc. were sand blasted and primed. After necessary repairs being effected the chassis was painted with black Acran two pack paint which gave a very hard and durable finish to facilitate future cleaning. The body, guards and various panels were taken to the panel beater who set about repairing the dings and bumps accumulated over the years. He also directed his attentions to the rusted sills, spare wheel compartment floor and rear seat floor.

While this was in progress I removed the door skins from their wooden frames - a painstaking job - and then replaced the rotted sections of the frames and reglued and tightened up the whole frames. The door skins were then cleaned, painted on the inside, reassembled and then taken to the panel shop for exterior painting. The spare chassis was also taken to the panel beater to ensure that the body was set up properly - especially while the sills were replaced.

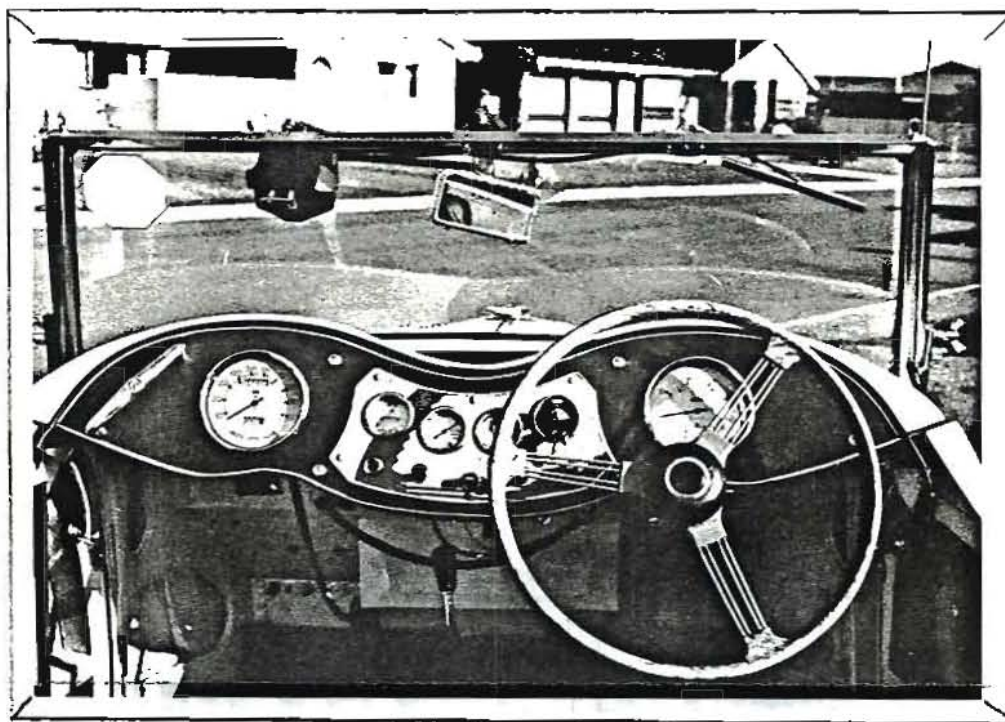
DASHBOARD DURING RESTORATION - GAUGES INSTALLED

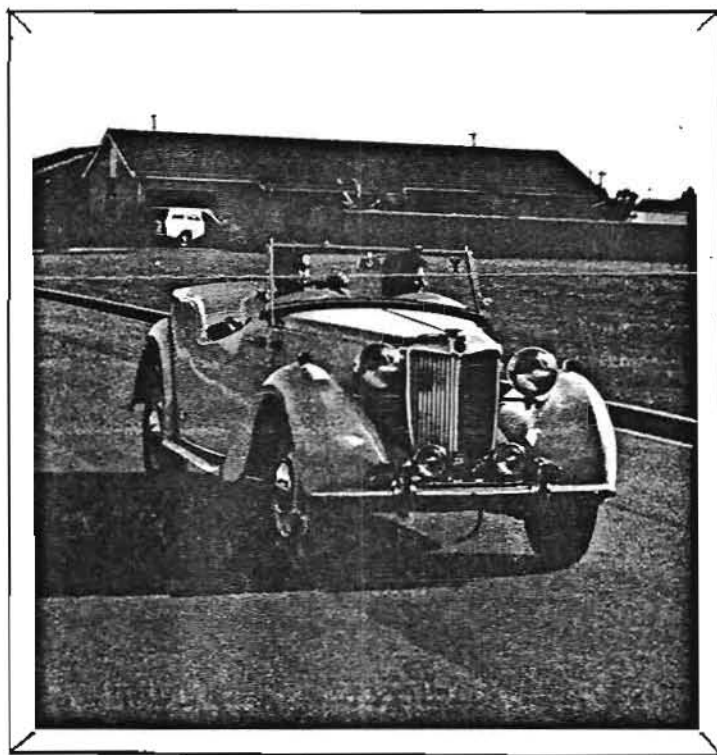
THE FIRST TRIP AROUND THE BLOCK
