Overhaul of Girling Luvax shock absorbers, Type PR 5 V

Karl Heinz Borchers, MG Y-Types Register

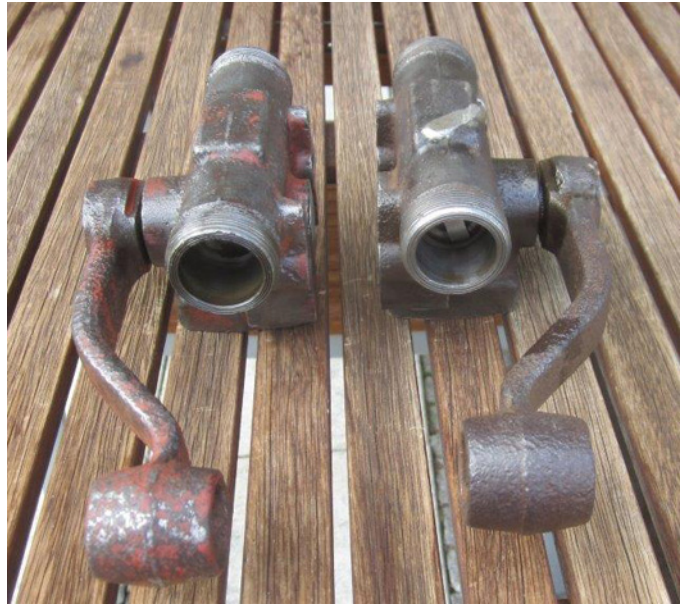
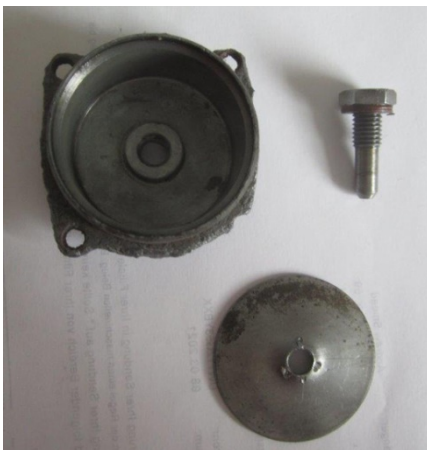
In 2010 I described the overhaul of Girling Luvax Type PR5X front shock absorbers. Now it is now the turn of the Type PR5 V shocks installed on the rear axle of the YA and YT. The YB has Type PR 6 installed, essentially the same except that they are a bit more heavy-duty. The occasion for the overhaul resulted from a request for a replacement left rear shock, which I unfortunately could not provide at the time. Then I discovered a pair of these shocks in my spare parts pool, but one of them, as was the case with the requester's shock, was unusable due to a crack. My shock had been welded at some time in the past so I started looking for good replacements. Thanks to the Internet, I found a seller in Berlin was selling both sides and sold them at a moderate price. I purchased them under the motto, "Buy when you can, then you have it when you need it." I began by documenting the two very different shocks, different due to the installation direction of the lever arms.

This difference makes it impossible to exchange the right and left shocks with each other. The lever arms are marked with faintly legible letters: **Left 1043/261 A, 87 31Y / Right 1043/261 A, 87 31X**. I started by disassembling the heavily corroded dampers. Carefully remove the cover of the damper housing (die-cast aluminum) without the use of force, otherwise it will break. If possible, do not damage the seal or you will have to find or make a new one. This lid also serves as an expansion tank in the event of temperature fluctuations, and the oil that collects runs back into the damper.

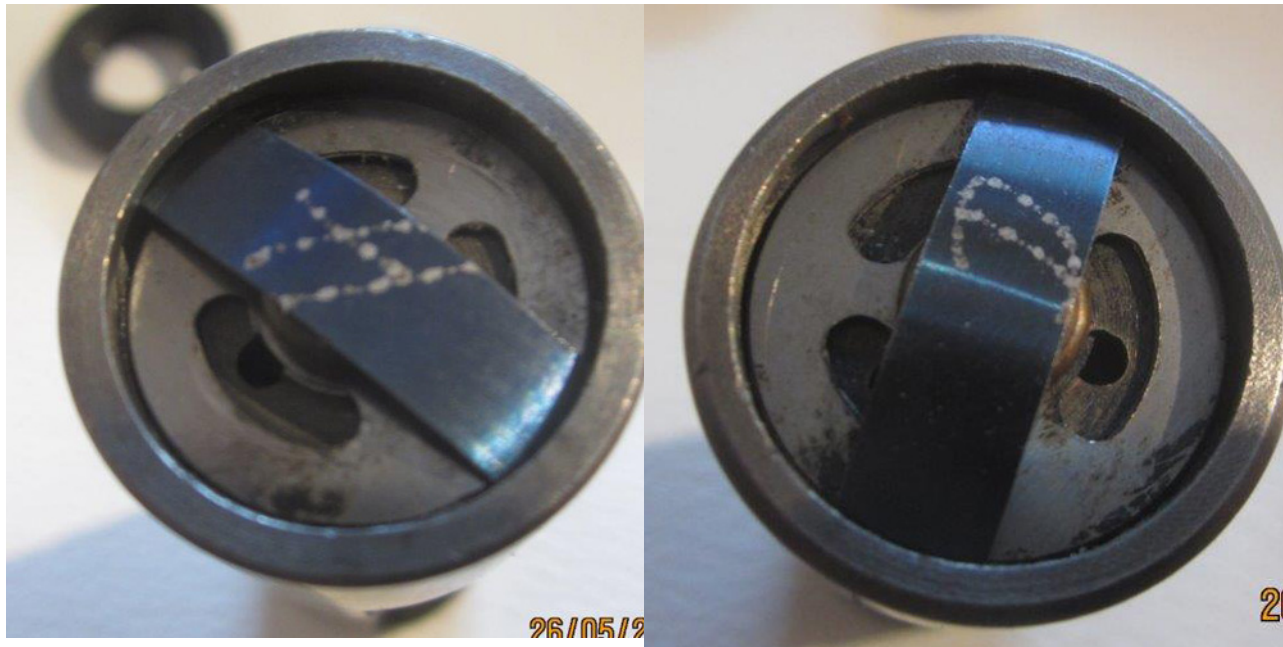
After unscrewing the cover, I discovered individual markings on the ends of the pistons.

I think the terms may mean “high” and “down” since the bores of the pistons would have to have different dimensions due to the characteristics of the shocks. I limited myself to reinstalling the pistons as they were to be safe. Since spare parts matching the existing bores are not available, I procured suitable (larger) oil seals and freeze plugs and rebored the cylinder accordingly on a lathe. I made up two auxiliary tools to bore out the holes to the new dimensions.

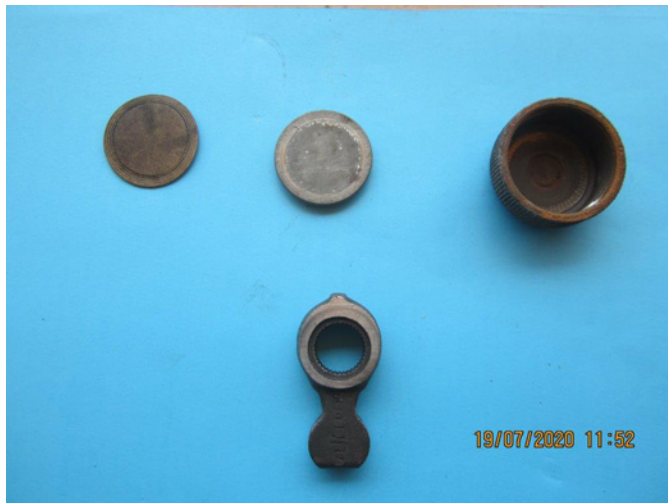
The end caps were fitted with Loctite thread sealant. Shown are the end cap with seal and spacer and the actuating cam.

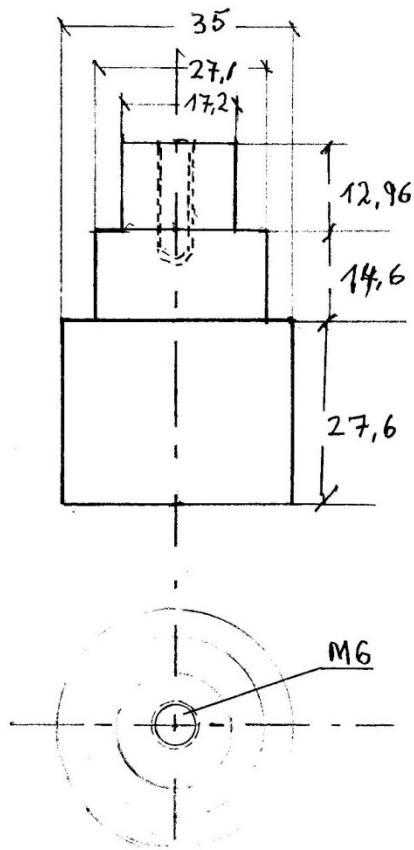
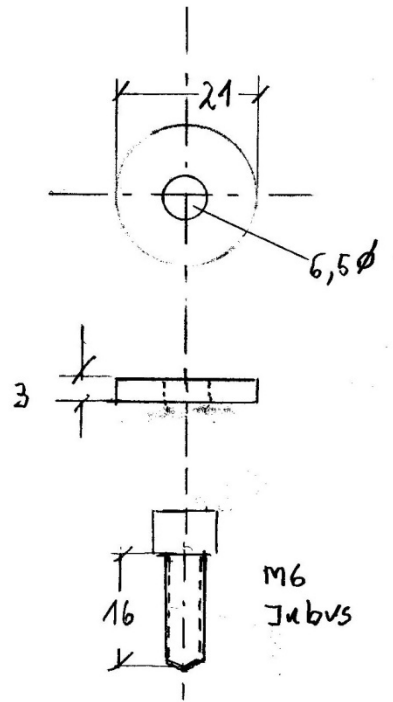
Tool 1

All measurements in mm

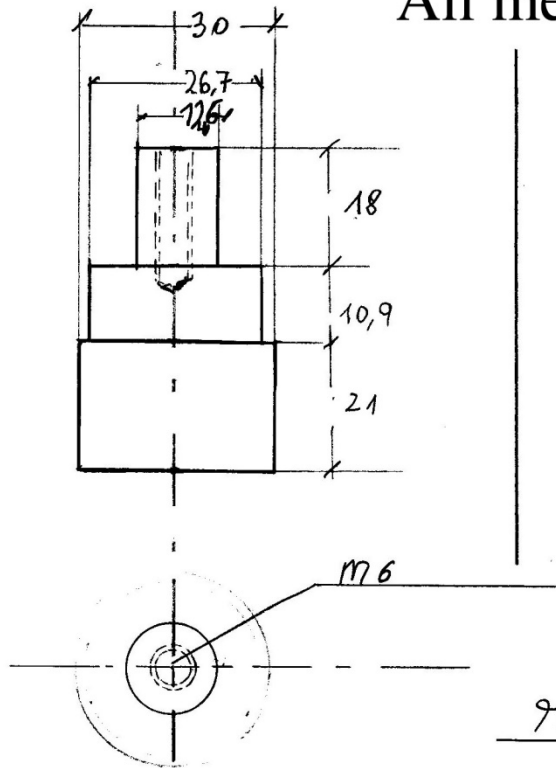
Tool 2

A dimensional drawing of the tool pictured at the top of page 3
