## Sun roof repairs by Rocky Von Dullen

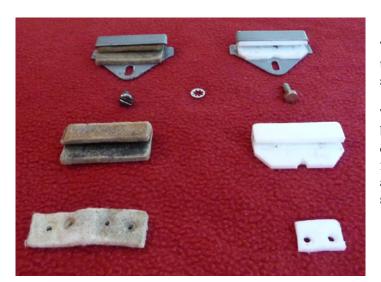
The left hand side of this photo shows the 'original" parts: the 1/8" thick front & rear felt slides, the 2BA pan head screw and the internal star lock washer.

The right hand side shows the "new" parts. Note that the bottom edges of the front PTFE slide may require chamfering to fit snuggly into the metal bracket. The holes for the rivets in the rear PTFE slides are countersunk to accept the rivet heads. Note that the heads fit against the side of the slide facing the track rail.

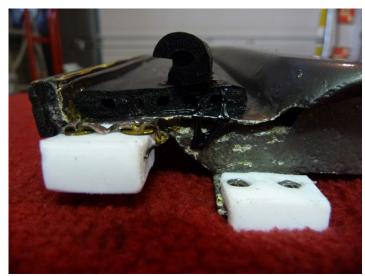
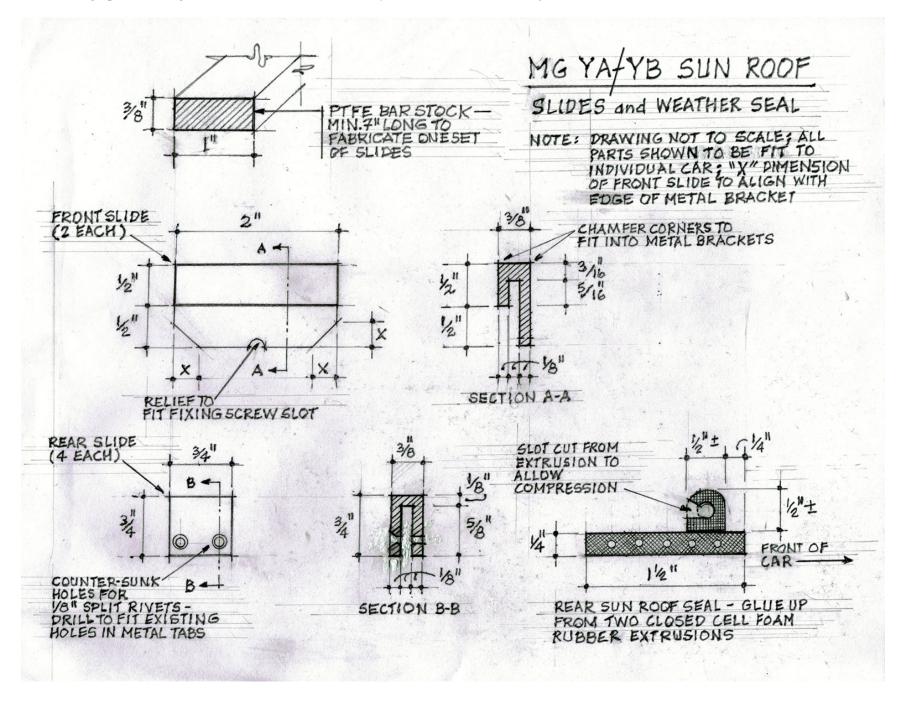
The other photos show the rear PTFE slides and rear seal as installed on the sunroof assembly. The upper and lower metal tabs can be seen "on edge." They are 3/4" X 3/4".
