PINS & BUSHES

Part 1

An occasional series on suspension overhauls. Here Brian Cox deals with threaded swivel pins and links used on four post-war MG models.

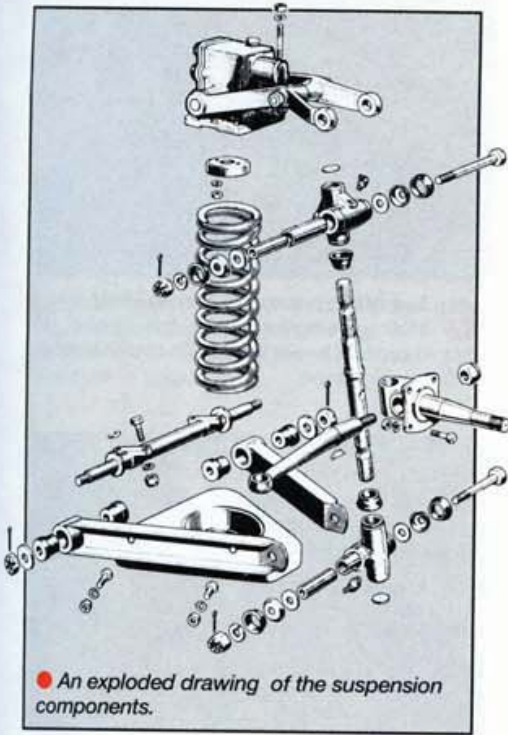
● An exploded drawing of the suspension components.

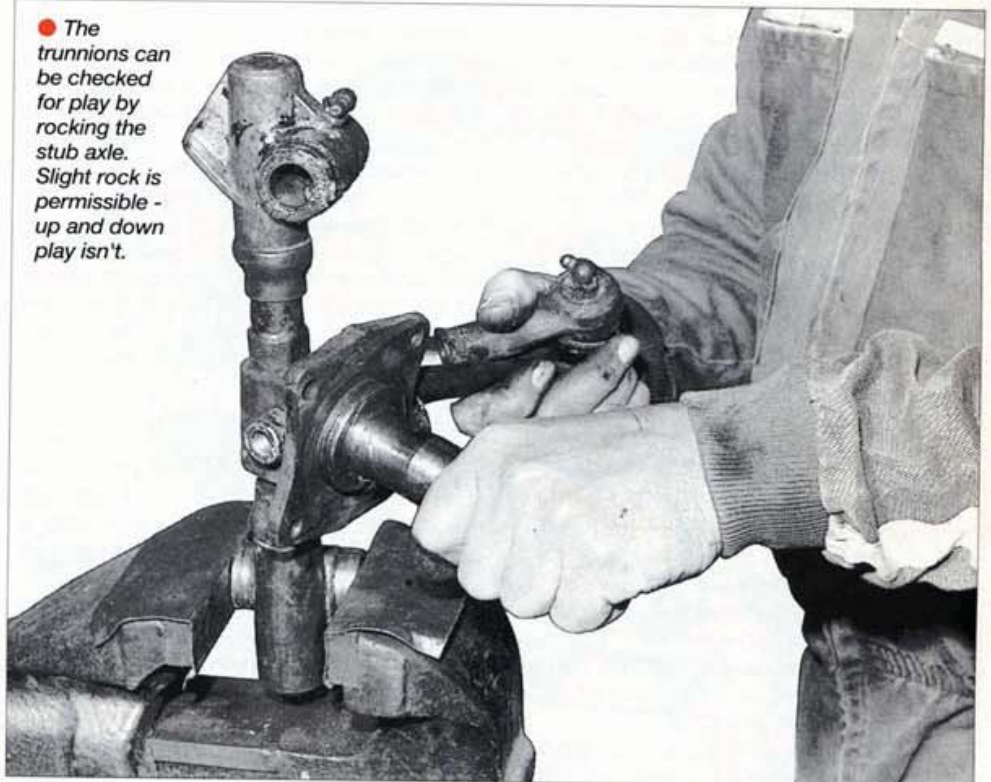
● The trunnions can be checked for play by rocking the stub axle. Slight rock is permissible - up and down play isn't.

The BMC manual says when new, the threaded trunnions are a free turning fit without slack and that "an appreciable amount of slack is permissible and they do not require renewal unless very slack." As the threaded bearing surface at each end of the swivel link is 2.5in. long, only slight rock should be noticeable when the trunnions are screwed on as far as they will go and then slackened by a couple of turns. If there is any up and down play, then both the trunnion and swivel pin will need replacing.

By wriggling my MG's swivel pin I was able to detect considerable rock in the lower trunnion, and very slight up and down play. The top trunnion was in much better condition with hardly a trace of rock and I deemed this fit for further service when fitted to an original unused BMC swivel pin I had acquired two or three years ago at an autojumble.

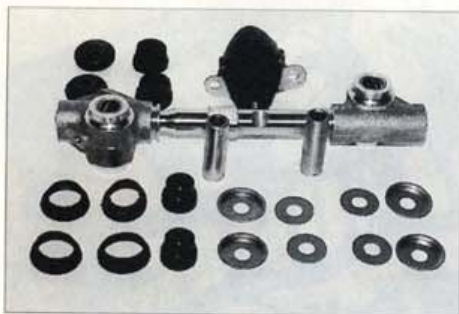
1 Parts I obtained from NTG to rebuild the offside front suspension. At the rear are anti-roll bar bushes and a new bump stop.

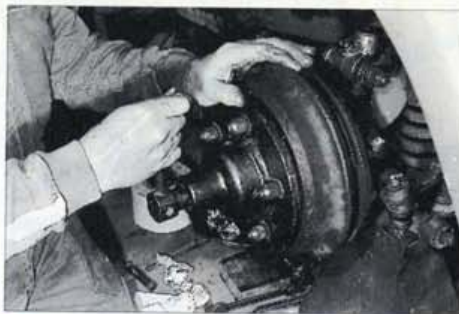
2 Using a puller to remove the hub; don't forget to slacken the adjusters first and to uncouple the brake hose and steering tie rod.

At some stage you will find it necessary to separate the hub from the stub axle, and it is probably easier to do this before dismantling anything else. Assuming your car has drum brakes, slacken the adjusters, then remove the hub grease cap followed by the cotter, nut and washer. Then draw off with a suitable puller. Check that the inner bearing or oil seal has not been left on the stub axle. You can prevent this happening next time by using Loctite Bearing Fit when re-fitting the bearing into its housing.

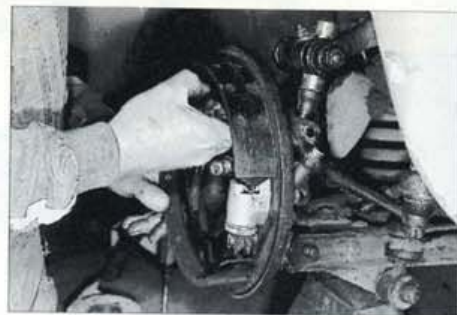
3 The brake backplate can be lifted off after undoing four bolts. It is a good idea to protect brake linings from oily hands with masking tape.

The brake backplate will also have to be removed or slackened at some stage to allow the bottom trunnion to be removed. The four fixing bolts are accessible on or off the car, so you can do it now or on the garage bench. (I chose to do it on the car).

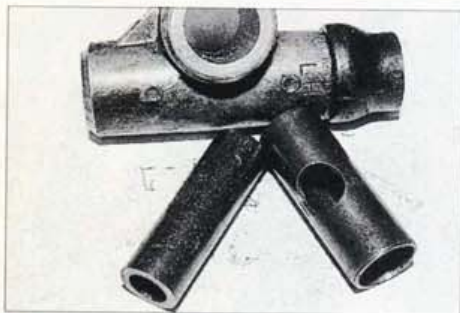
7 The corroded distance tube and worn bush removed from the bottom trunnion. These tend to wear more than the top ones.

Both distance tubes were slack in the trunnion bushes and the bottom one was badly corroded too. This is not uncommon and emphasises the importance of checking the condition of the trunnion seals regularly.

If excess play appears to be limited to the fulcrum pin distance tubes/bushes, then you may get away with replacing just these components. I did on one top trunnion.

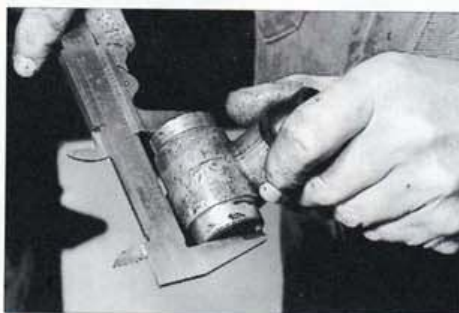
8 Check measurement across the thrust faces of the trunnions. It should be 59.11mm plus or minus .04mm. Replace if badly worn.

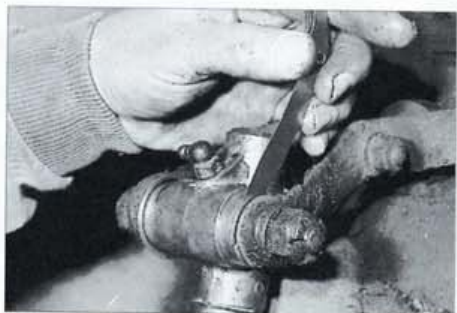
9 There must be .008in. - .013in. clearance between the trunnions and thrust washers when fulcrum bolt is fully tightened. Seals omitted for clarity.

Before the stub axle is permanently installed on the car, it is very important that you check the total end clearance between the trunnion and the thrust washers which should be .008in. - 0.13in (.2mm to .33mm). If you examine the hardened fulcrum pin distance tubes carefully you will see that they protrude slightly when placed in the trunnions to give the necessary clearance.

When the fulcrum pin is bolted up tight on the car this allows the trunnion to pivot on the distance tube. Without this clearance the suspension will be rock solid and other suspension components will be damaged. This

When you are happy the necessary clearance is present, you can go ahead and refit the stub axle permanently, not forgetting to fit new cotter pins (or lock nuts) to the two fulcrum bolts when fully tightened.

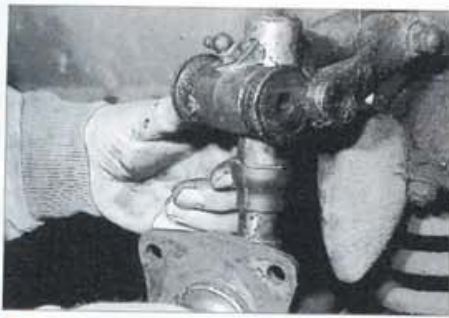
4 Before removing or replacing the stub axle, slacken the bolt linking the damper arms and use a piece of metal to keep arms apart.

balljoints. Remove the cotter and nut from the top trunnion fulcrum bolt and slacken the bolt linking the twin damper arms and wedge them apart to make withdrawal and replacement of the trunnion easier. But don't remove the trunnion bolt yet.

Don't forget to re-tighten the front wishbone arm bolts and the bolt linking the damper arms.

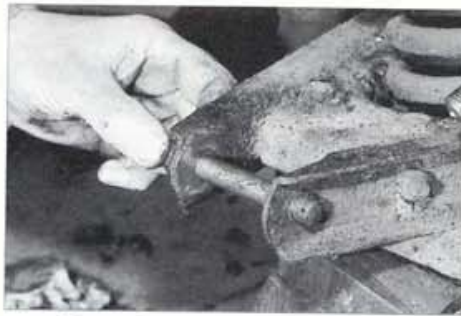
5 Check the lower fulcrum bolt holes on the wishbone arms for elongation. Replace arms that are faulty - MGB rear arms fit.

The only other suspension part I scrutinised closely was the stub axle mounting holes in the lower wishbone arms, which if elongated can affect the wheel camber and allow movement of the stub axle. The holes should be 21/64in. (8.33mm) and if they had become elongated the arms would have needed changing.

Several parts from the MGB front suspension are interchangeable with the earlier post war MGs. The rear lower wishbone arms can be used to replace worn components on Y and T Types and also the MGA. Other parts you can use are the distance tubes, bottom fulcrum bushes and swivel pin fulcrum bolts. If the bottom wishbone rubber bushes are worn, it is recommended you replace these with the MGB V8 Metalastik type.

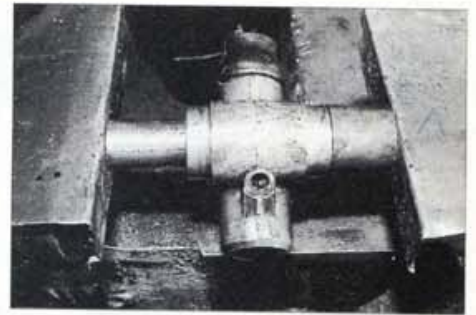
6 Use suitable diameter tubing in a vice fitted with soft jaws to press out a worn trunnion bush. New bush will need reaming. New trunnions have ready-reamed bushes.

I used the vice to press in a new trunnion-bush taking care that the hole in the bush lined up with the threaded bore. This gives the necessary clearance to the waisted swivel pin and also acts an oilway. I then took the trunnion to Couzens Engineering of Stamford (Tel: 0780

56818) for the bush to be accurately reamed.

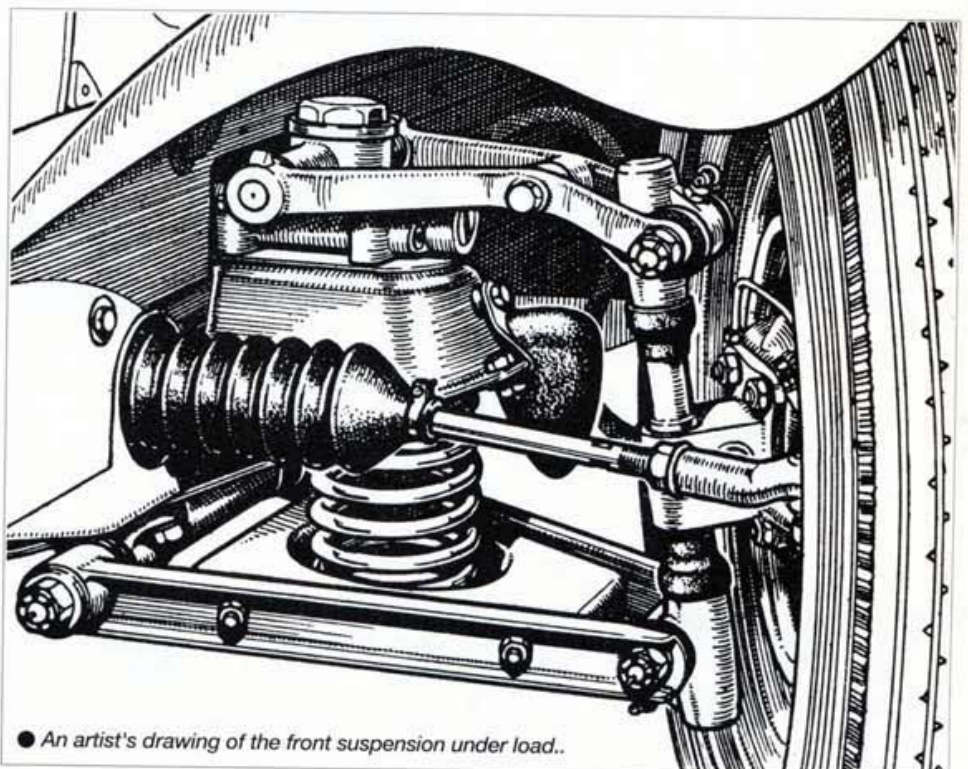
● An artist's drawing of the front suspension under load..
