## Addition of a Remote Brake Fluid Reservoir to MG YB TD and TF (TA TB TC YA with mods)

**Addition of a  
Remote Brake  
Fluid Reservoir  
to MG YB TD's  
and TF's (TA TB  
TC YA with  
mods) page 38**

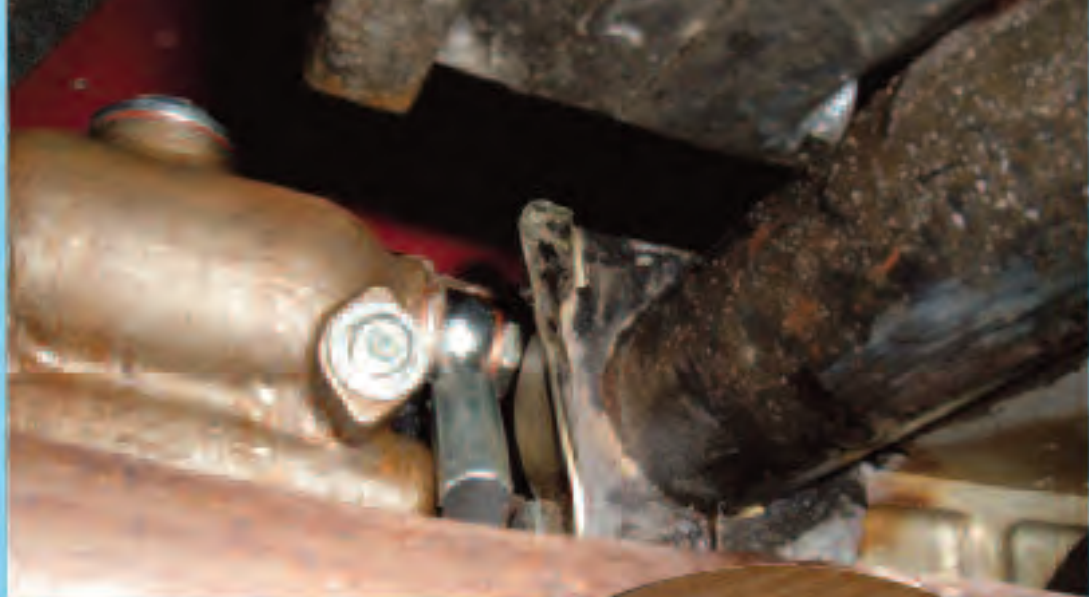
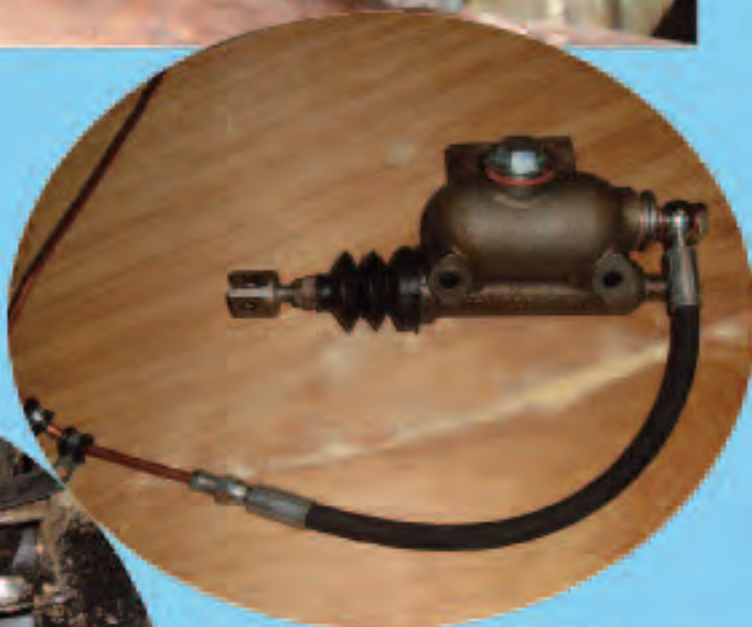
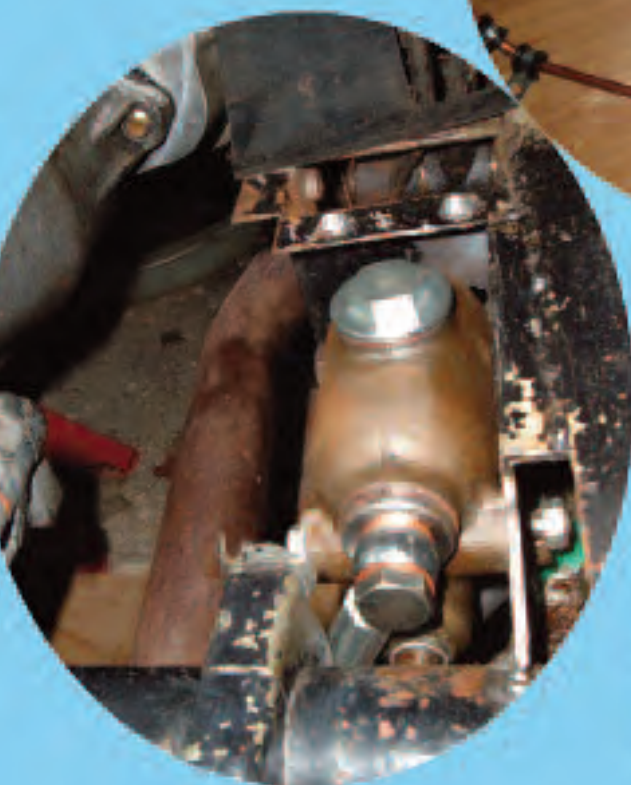
Even with the steering wheel removed it is difficult to position ones head to see down into the opening and pretty well impossible to add fluid and check the fluid level. The only solution appears to be one which involves a mirror, torch and a purpose made dipstick. The fitting of a remote reservoir addresses both access and potential low fluid levels, eases the bleeding of the brakes, and enables the car user to see any drop in fluid level by simply lifting the bonnet. The sketch shows how I installed a remote reservoir to my TF.

supports on the cross member for the 5 speed gearbox fitted onto my car, and I found the best solution involved a banjo off the front of the master cylinder with a 1/4 in feed pipe up to the remote reservoir which I located on the outside face of the tool box under the bonnet. (See photo) Please note that no modifications to the existing master cylinder are required other than the replacement of the filler and cleaning plugs. However as the work necessitates removal of the master cylinder the owner may take the opportunity to have the cylinder refurbished by a specialist, say Past Parts of Bury St Edmunds, beforehand.

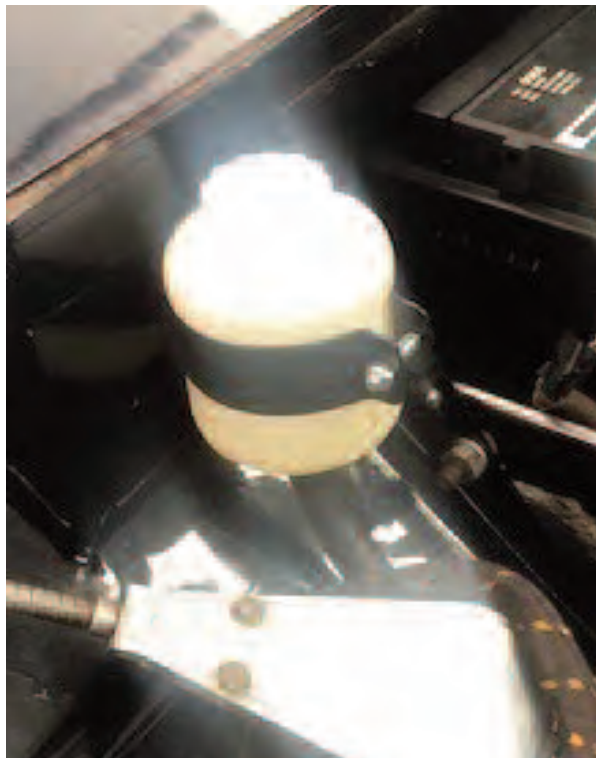
satisfactory condition for reuse after cleaning. The new Lockheed brake fluid reservoir was purchased from Carbuilder.com at a cost of £13.20. A photo of the new reservoir mounted under the bonnet on the front corner of the toolbox is shown below:

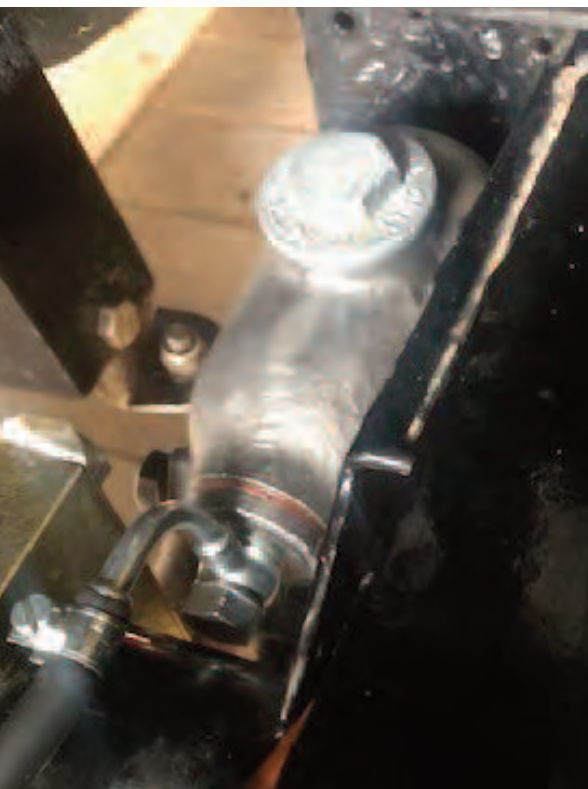
The majority of the pipe run is copper. It is wise to check there is a good rate of flow of fluid through the pipe from the reservoir to the master cylinder, if not then a problem can arise when bleeding the brakes'. Below is a photo of the refurbished master cylinder showing the new fluid feed pipe:

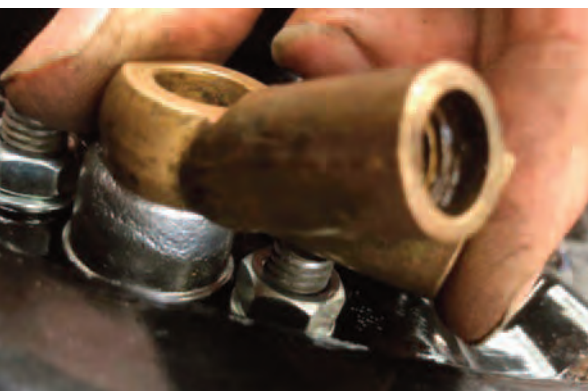
The culprit was found to be the wheel cylinder stud which was a shade too long so that when the banjo bolt was tightened and the copper washers compressed, the stud interfered with the banjo causing a strain on the joint and hence the leak. The simple remedy was to shorten the stud slightly so that the interference of stud against banjo no longer took place. See photo below:
