# YT 4265 – a restoration

## How & why it happened

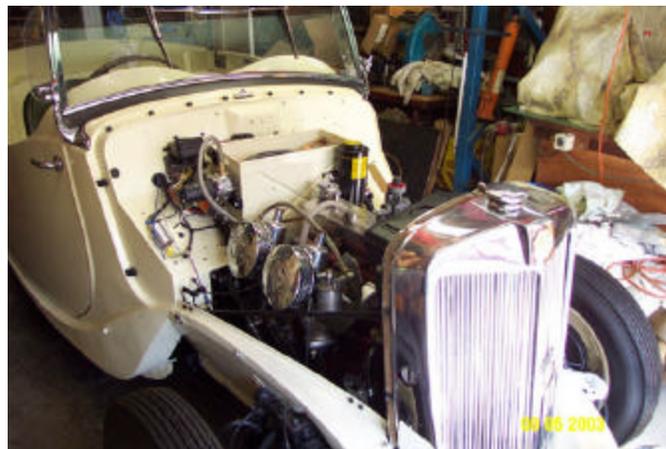
Now was the time to fit the motor and gearbox which had been reconditioned some 5 years ago. They were mounted on new mounts and the engine steady bar fitted and adjusted. All ancillaries such as carburettors, water-pump, generator, starter, oil filter etc. were fitted as well as a new exhaust system. Here I deviated from standard by fitting a larger tail pipe. All of this was very straight-forward, and I was now the proud possessor of a restored rolling chassis - being totally unaware at this juncture of the dramas in store for me. I don't have the original oil bath air cleaner so I have fitted two nice pancake filters which are embossed with the MG logo. I find these are more convenient for tuning than the oil bath cleaner.

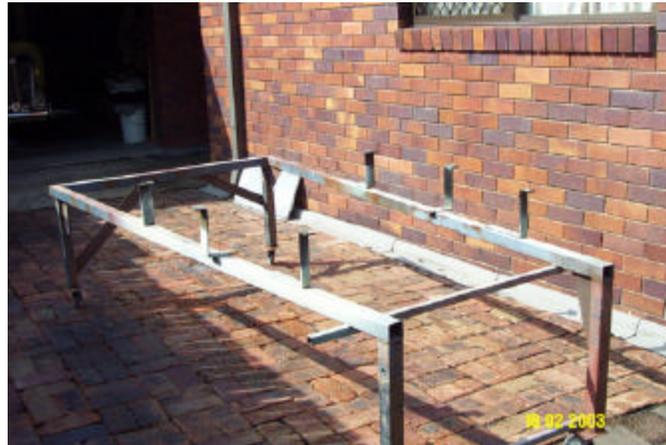
Through the “Y” web site I met Geoff Meller another Y enthusiast who was restoring a YT. As it turned Geoff lived near Grafton only about 140 km from Ballina. Geoff was further ahead with his restoration than I was and offered me the loan of a trolley he had fabricated to mount his YT body on during its restoration. This trolley is really excellent and facilitates body work and painting of the tub. It consists of a frame with mounting brackets to match the mounting points on the chassis and body. The whole contraption is mounted on 4 castors situated at each corner of the frame. Thus as well as raising the tub

one metre above the floor it is very easy to move around while working on the body, particularly good if working in a somewhat confined space.

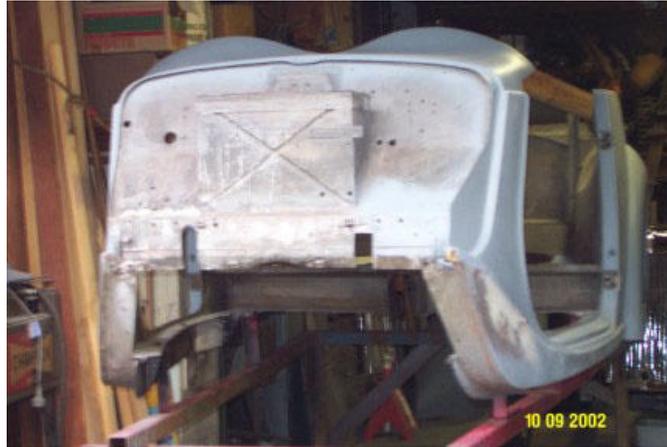
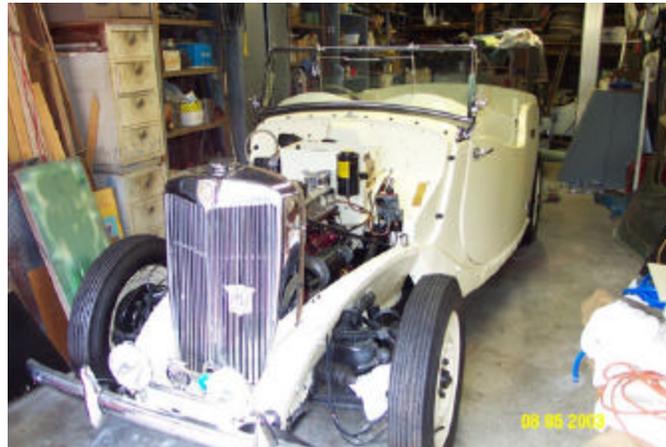
Having made sure that every thing would bolt together satisfactorily the body, guards, sills and doors were dismantled, the body removed from the chassis and mounted onto Geoff Meller's trolley. The hard work now began. Rust and paint were removed mechanically and the repair of guards, doors and sills began. As each component was repaired it was undercoated and numerous coats of spray putty were applied followed by sanding to get as good a surface as possible. Even so the finish is not really comparable to a professional job – but I have the satisfaction of personal achievement. Spray painting was carried out in the open air on still fine days as I do not have the luxury of a spray booth. The body was first and was sprayed on the trolley. Body colour is sequoia

cream mixed to the original formula. The manufacturer of the originally specified tints was no longer producing them but was very helpful in advising modern substitutes. Paint is acrylic lacquer. The underside of the tub was painted gloss black followed by an application of black body schultz which is fairly chip resistant and a rust preventative. The inside of the boot was painted black. The tub was then placed on the chassis with insertion thick rubber placed under each mounting point and bolted down.
