## THE CLASSIC 'Y'

The Newsletter of the M.G. 'Y' Type Register.  
Volume 16. No.118. August 1993.

## Y TYPE STEERING COLUMN ELECTRICS

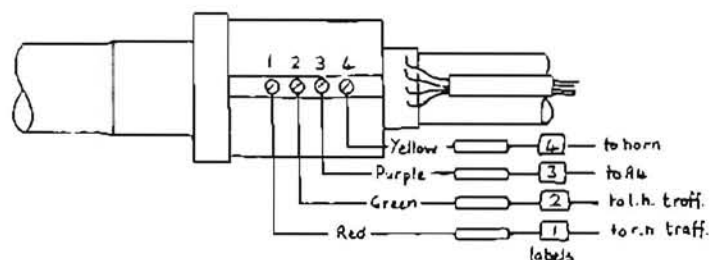
Figure 1 — Slipring unit connections

**TEST 2** Switch on ignition. Connect test lead between terminals 1 and 3 on the slipring unit on the steering column. (No. 1 terminal is the one nearest the steering wheel — see fig. 1. You need not disconnect the wires to the slipring unit).

**TEST 3** If the AUX IGN fuse between terminals A3 and A4 on the regulator (YA) or fuse box (YB) blows when a trafficator is switched on, there is a short to earth between the A4 terminal and the trafficator. A few inches from the slipring unit are four snap connectors. Label these 1, 2, 3 and 4 as shown in fig. 1 using self-adhesive labels. Disconnect the wires either at the snap connectors or slipring unit and repeat test 2 (1 and 3, 2 and 3) but this time connecting the test lead to the wires you have just labelled. If the trafficators work with the ignition switched on and the fuse doesn't now blow, then the short is in the steering column wiring or at the steering wheel switch. If the fuse blows for both 1 and 3 connected and 2 and 3 connected in turn (expensive on fuses, this!), look for an earth short between the regulator and slip ring unit. The short is between the wire labelled 1 and the r.h. trafficator if the fuse only blows when 1 and 3 are connected, or between wire 2 and the l.h. trafficator if the fuse only blows with 2 and 3 connected. When the fault has been found and repaired, reconnect the wires.

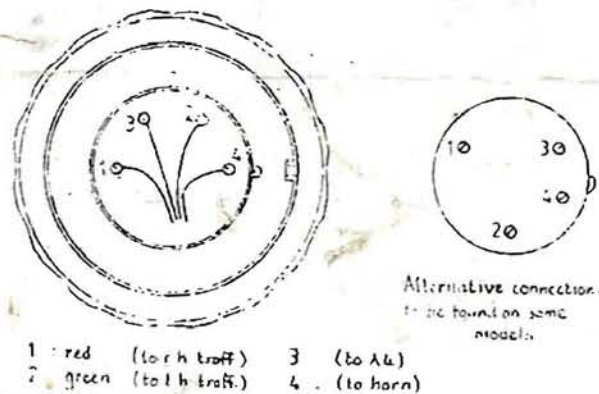
Figure 2 — Underneath of Steering Wheel Switch

**TEST 4** To check if the slipring unit is working.

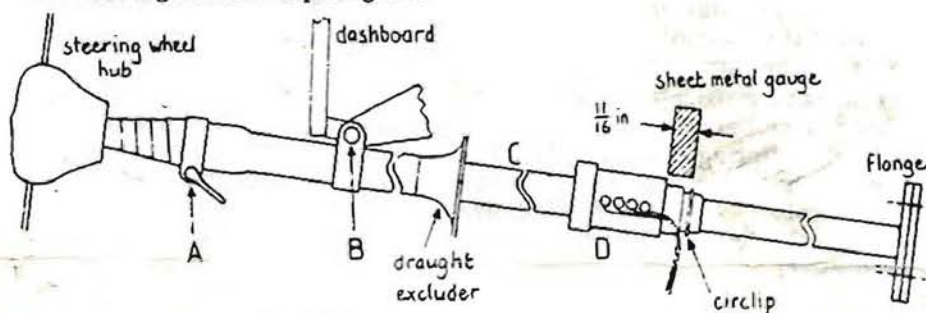
Figure 3: Steering column assembly

Neither the trafficators nor the horn will work correctly if there are poor or misaligned contacts at the slip-ring unit. Since this article is mainly about electrics, I will not go into details about steering column dismantling. If, however, clamps A and B are slackened and the draught excluder undone and outer shaft C is worked up towards the steering wheel, the slip-ring outer plastic casing D should move just far enough to expose all four springy contacts fixed to the plastic inner part of the slip-ring assembly. Check that the contacts still retain their springiness, clean with a rag, smear vaseline (not grease!) over the contact studs and slide the outer shaft down to its original position. It may need to be twisted back and forth to help it move. I find the best way to line up the assembly correctly is to cut a gauge  $11/16$ " wide out of a strip of cardboard or sheet metal (shown shaded on figure 3). The slip-ring unit is correctly lined up when the gauge just fits between the circlip and the end of the outer plastic casing. Bolt up B and check with the gauge again. Tighten A and refit the draught excluder.

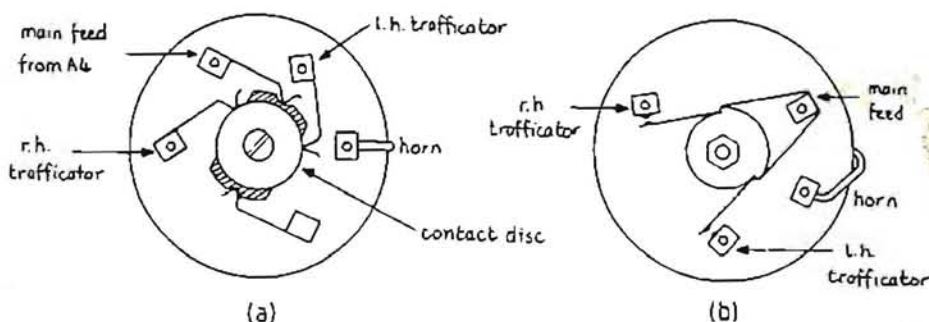
Figure 4 : Trafficator switch contacts

Remove the countersunk screw in the steering wheel hub and lift out the switch unit. Before removing the four wires make a note of their relative positions. With the cover disc removed the contacts should appear as shown in either figure 4a or figure 4b. Check that the contact blades are correctly in position, and that the contact disc turns with the trafficator control ring. The contact disc can be removed by undoing the central screw or nut, and the springy contact blades can be reshaped if necessary using fine-nosed pliers. In the type shown in figure 4a replace the contact disc and make sure the brass contacts press on the copper segments when the control ring is turned. I repaired one contact by cutting a new strip from thin brass and soldering it onto the terminal post. The plastic part of the contact disc should be perfectly circular, if it isn't, build it up with Araldite and carefully file to shape. If there are any faults in the timing mechanism I suggest taking it to a clock repairer!

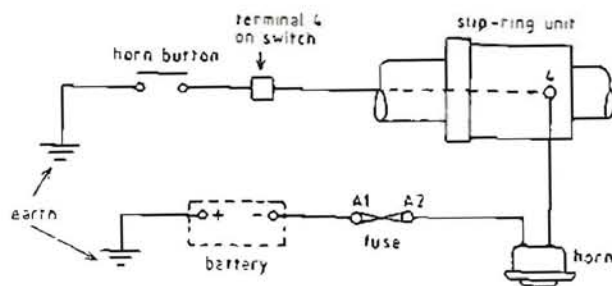
Figure 1 - Horn Circuit

- 1) Connect one end of a test lead to number 4 terminal on the slip-ring unit (the one nearest the front of the car) and the other end to a good earth, preferably the battery earth terminal. If the horn sounds the fault is in the slip-ring unit or the steering wheel horn switch — go to test 4 below.
- 2) If the horn does not sound check it by disconnecting the wires to it and re-connecting it directly to the battery terminals. The horn should work. If it doesn't, then the horn itself is at fault.
- 3) If the horn works, check the cable from the regulator (or fuse box in the YB) terminal A2 to the slip-ring unit.

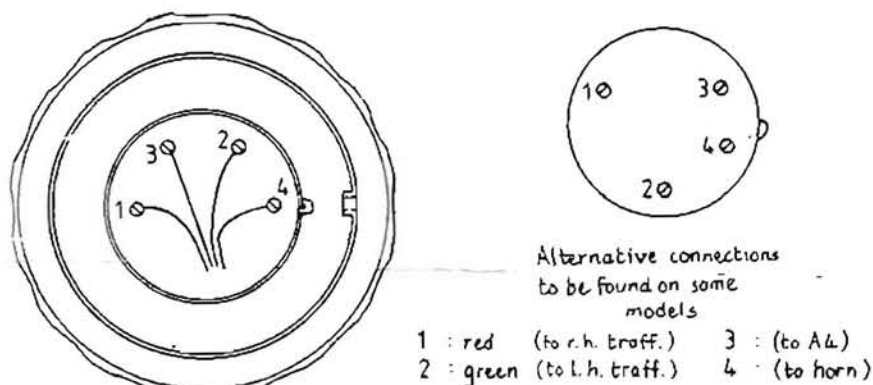
Figure 2 - Underneath of Steering Wheel Switch

- 4) To check the slip-ring unit, remove the screw which holds the steering wheel switch in the steering wheel hub and gently pull out the switch. Don't undo the wires. Connect a test lead from terminal 4 on the switch unit (see figure 2) to earth at the battery. (Terminal 4 is the one with a yellow wire and a second wire running from the terminal post into the bowels of the switch unit). If the horn sounds, the slip-ring unit and horn wiring are O.K., but make sure the test is carried out as the steering is turned from lock to lock. If the horn does not sound, check the alignment of the slip-ring unit (already dealt with).

Remove the single countersunk screw holding the steering wheel switch unit and gently pull out the switch unit. Switch on the ignition. Refer to figure 2. Connect the test lead between 1 (red) and 3 (purple) and the r.h. trafficator should work. Connect between 2 (green) and 3 (purple) and the l.h. trafficator should work. These tests should be carried out with the steering wheel at different positions between full lock one way and full lock the other. If the trafficators do work, then the slipring unit is working correctly, and the wiring in the steering column is all right. The fault most probably lies in the steering wheel switch unit. If as a result of this test the trafficators do not work then there is a fault between the slipring unit and the steering wheel switch unit, or in the slipring unit itself. Check the slipring unit as outlined in the next section and if that doesn't cure the fault go on to the section on steering column wiring. If the AUX IGN fuse blows there is a short to earth, probably in the steering column wiring.

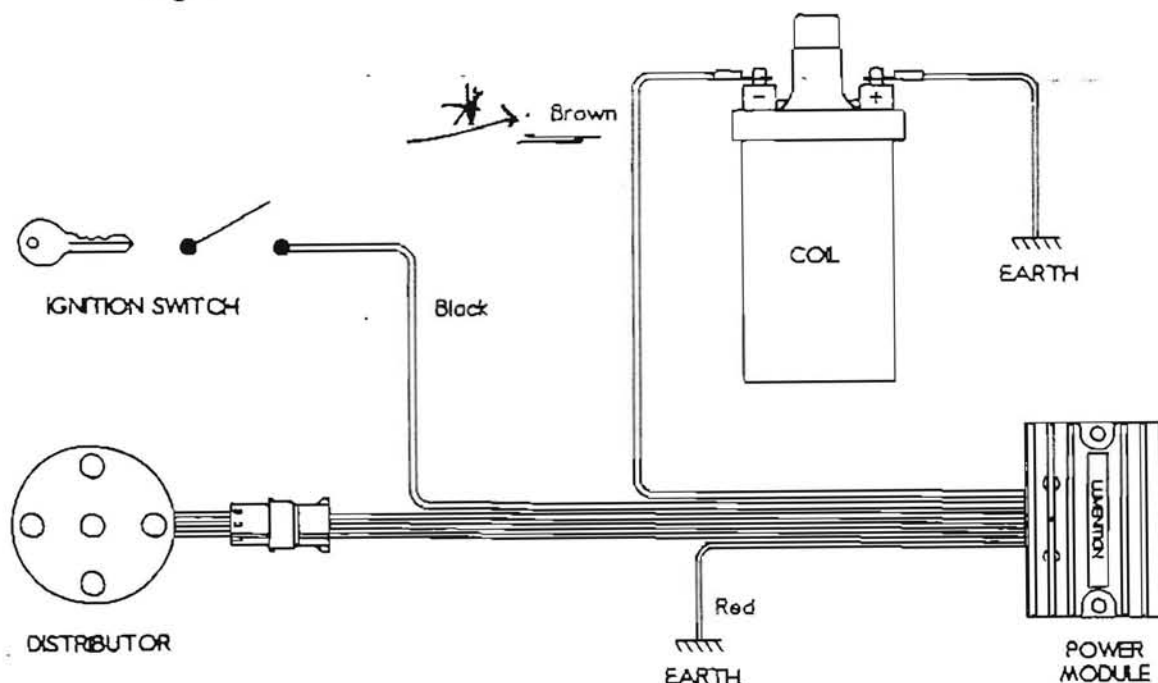
Fig. 1

Referring to figure 1 it can be seen that the chief area of attention is to the module and coil power connections.

In this case the module ground wire should not be connected under the mounting screw instead it should connect to the ignition switched ground.

The module power line (red wire) can be chassis connected, for example the eyelet terminal can be screwed down with the module mounting screw.

\* NB: the ignition coil -ve terminal is still connected to the brown wire.

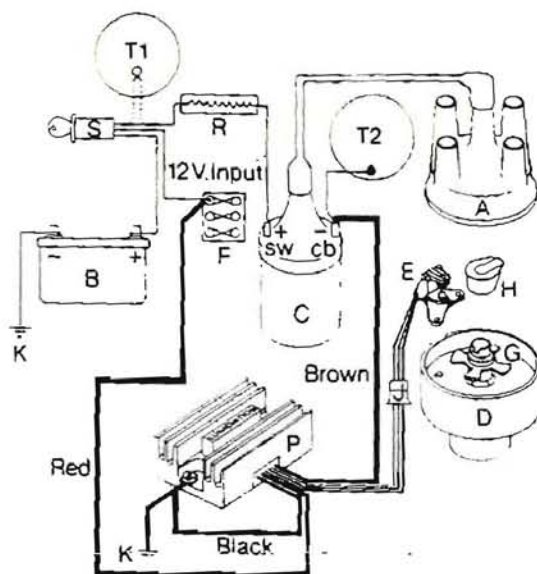
| A Distributor Cap | J Connector |
| B Battery | K Earth |
| C Coil | P Power Module |
| D Distributor | R Resistor |
| E Optical Switch | S Ignition Switch |
| F Fuse Box | T1 Impulse Tachometer |
| G Chopper | T2 Voltage Tachometer |
| H Rotor | |

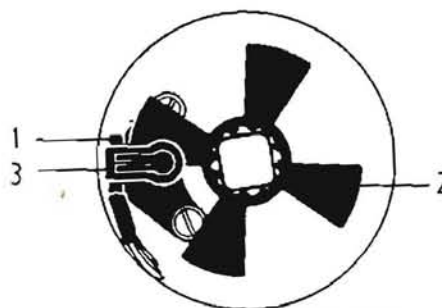
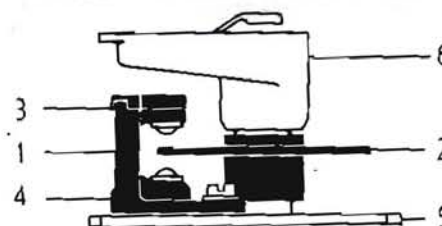
First is the Optical Switch, this contains a light emitting diode (LED) which sits on the switch bracket opposite a matching silicon phototransistor which receives or "sees" the infra red beam.

Secondly, the interruptor called a chopper which is fitted over the cam, rotates interrupting the beam of light causing a pulse.

- 1 Optical Switch
- 2 Chopper
- 3 Photo Transistor
- 4 Light Emitting Diode
- 5 Base Plate
- 6 Rotor
