The Classic "Y"

Issue No.134 October 1996.

The Newsletter of The M.G. "Y" Type Register

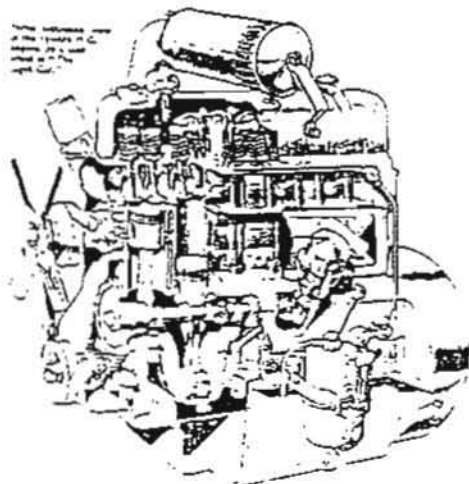
It is easy to be clever after the event, so it is a little unkind to slate the design. It is, after all, only an improved 1935 Morris 10 h.p. engine, with the state-of-the-art technology of those pre-World War II days. The diagram above is not accurate - the sump sits one eighth of an inch BELOW the crankshaft centre line. Note that the oil-thrower washer sits with its face curved AWAY from the timing chain sprocket. I have stripped down engines and found this VERY IMPORTANT washer missing.

The ideal gasket surface is ONE continuous flat surface, as on the B.M.C. "B" Series sump. This engine's skirt extends down below the main bearings, where the sump and the bearing caps make a flat join. Yes, it leaks elsewhere, I know, but its sump is a good design. The XPAG sump gasket is, to be kind, a compromise. It needs no less than FIVE bits to seal it. It follows the normal Morris Engines practice of bolting the sump up to the gearbox, giving a rigid join but a hidden gasket surface around the rear main bearing.

The rear end is just as difficult. The cork insert that sits in the gulley around the rear main bearing cap has to be fitted so that it too traps the gasket. In gasket sets found at autojumbles, it is this piece that is invariably so dried out it cracks, fails to bend, or breaks in half. Old gasket sets are hard to find, and are usually for the Wolseley 4/44 (same gasket set, but very different sump).
