Sealing the Sender Unit

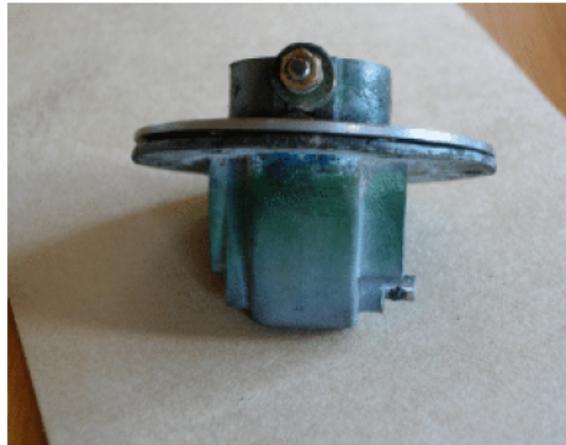
Originally the flat flange of the sender unit fitted to a flat area of the tank. Machine screws pass through the sender unit flange and skin of the tank and into tapped holes in a support ring secured inside the tank. A gasket evens out any slight blemishes in the matching surfaces and provides a petrol-tight seal.

Over the years, especially if the car is left for any time, moisture may penetrate the gasket which expands. This causes the flange to distort between the machine screws. Petrol can now seep past the gasket. A common answer is to fit a slightly thicker gasket to take up the distortion. However, the softness of the Mazak will result in further distortion of the

flange. Sealing agents may work in the short term, but the scenario referred to in the opening paragraph, sealing the hole with bent metal, won't work in the long term.

Faced with this problem I went back to first principles. Since the Mazak is weak, a strengthening steel ring was turned and drilled to fit over the flange. Carefully, the flange was flattened by gentle tapping with a hammer. Although most of the distortion was removed there was still considerable room for improvement as can be seen in the photograph. The solution

was to turn a flat surface using the lathe.
