THE CLASSIC 'Y'

The Newsletter of the M.G. 'Y' Type Register.
Volume 16. No.116. April 1993.

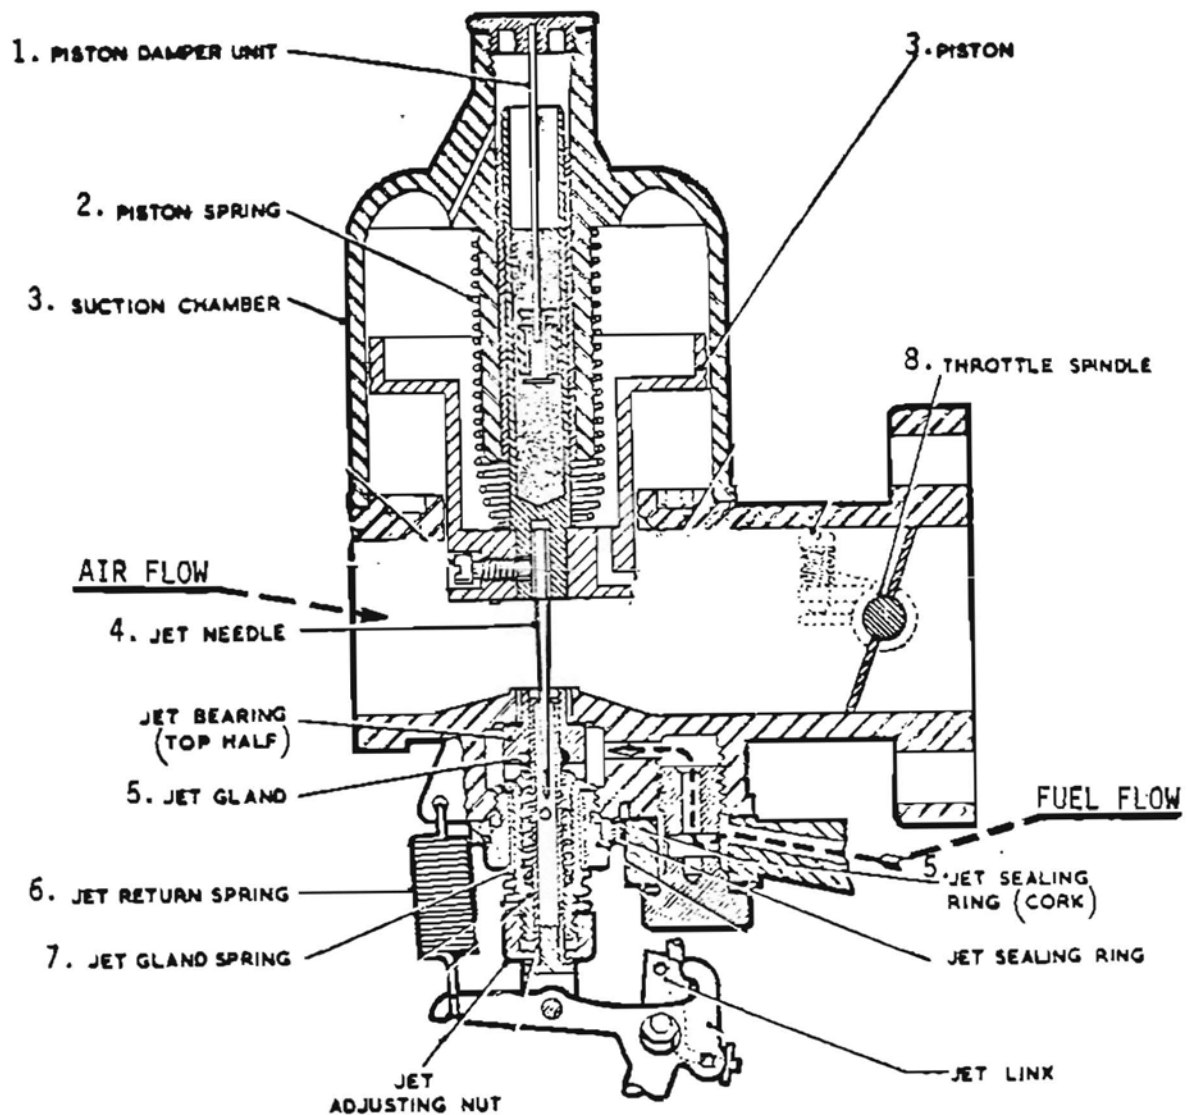
COMMON FAULTS

| 1. | 4. | 8. Worn spindle housing area (bushing) or shafts caused air leak |
| 2. | 5. Worn or cracked sealer | |
| 3. | 6. Choke not fully closed due to weak spring | |
| A) Dirty piston B) Sticking piston | 7. Jet sealer not sealed due to weak spring | |

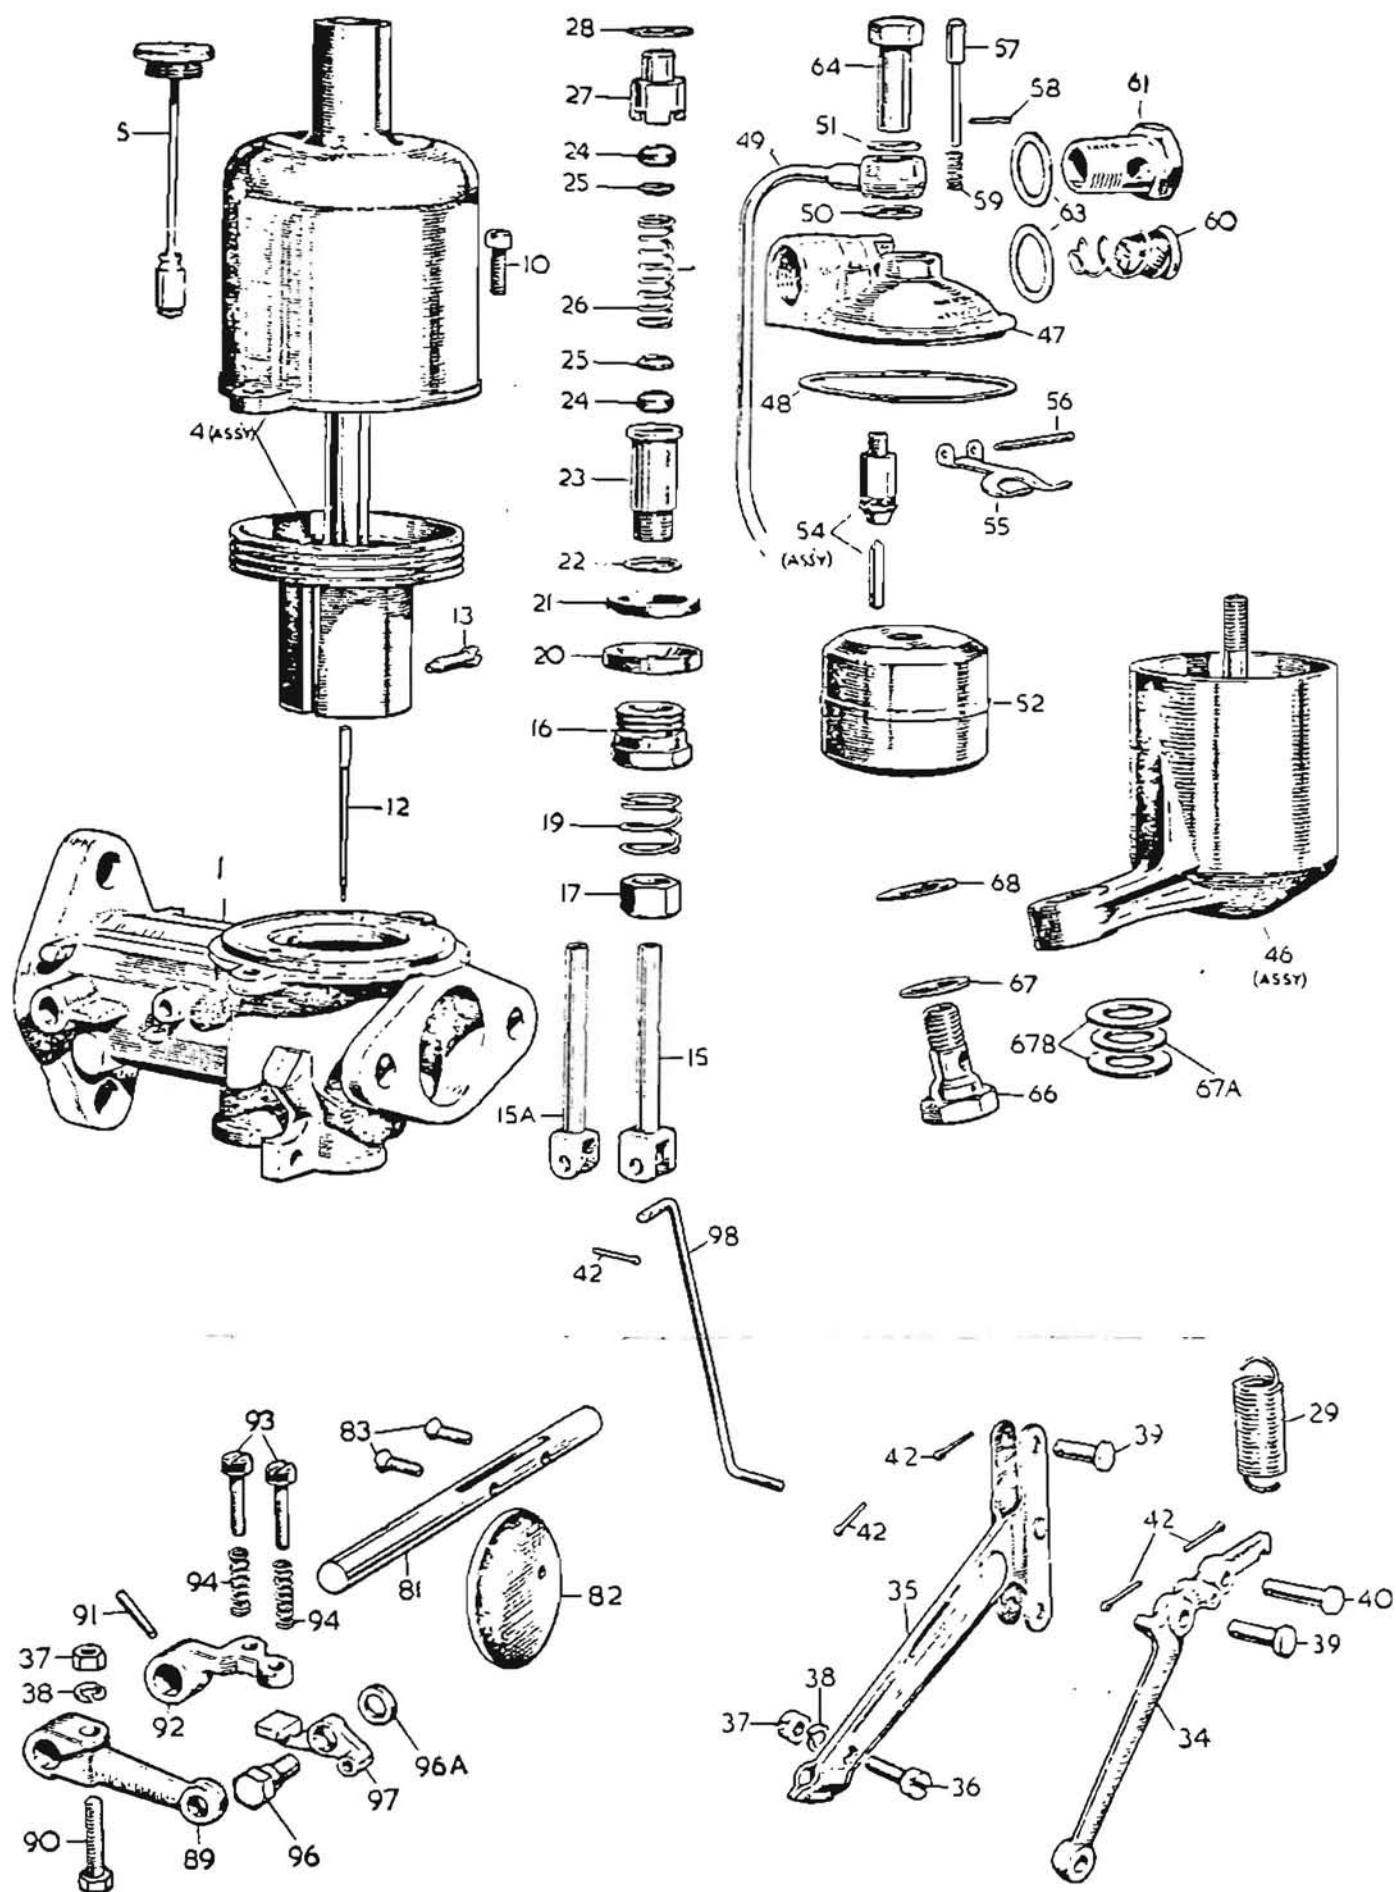
SINGLE CARBURETTER (Type H2)
