THE CLASSIC Y

The Newsletter of the M.G. 'Y' Type Register. Volume 17. -No.123. June 1994.

OVERHAULING THE DISTRIBUTOR By L. T. SMITH

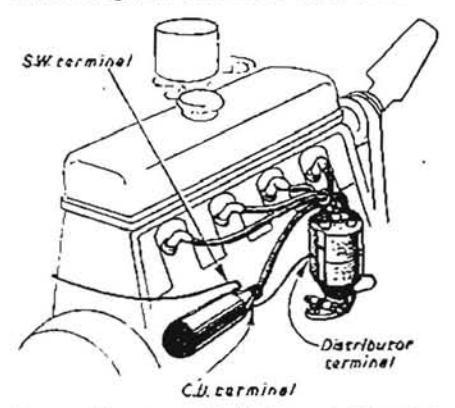
Fig. 1.- The arrows indicate probable points of resistance.

Any undue resistance in the external primary circuit is reflected by a drop in the H.T. current which invariably results in difficult starting and severe misfiring. Points to look for are the lead tags beneath the coil terminals S.W. and C.B. and also beneath the distributor terminal (Fig. t). If necessary, these should be cleaned with fine emery paper, and care should be taken not to overtighten or strain the terminals when replacing.

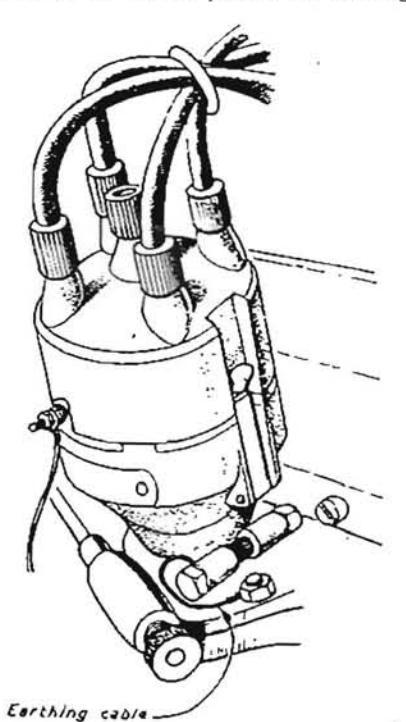
Fig. 2.—Where an earthing cable is provided on the distributor, it should be secure and intact.

when replacing. In order to ensure a good earth connection, a practice is often made of providing a flexible earthing cable beneath the distributor clamping bolt and one of the two bolts which secure the distributor to the crankcase (Fig. 2). Although the distributor will in all probability function

perfectly satisfactorily without this cable, nevertheless the cable is provided for a definite purpose, and it is advisable to give an occasional glance at same to make sure that it is intact.

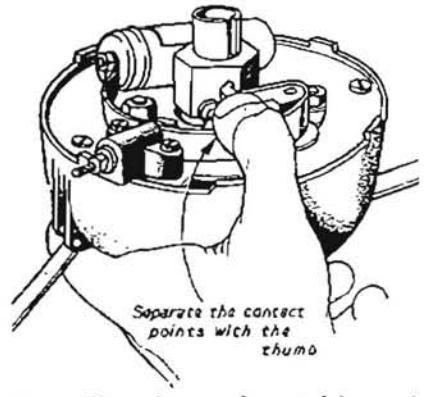
Fig. 3.—The points are inspected by gently opening with the thumb.

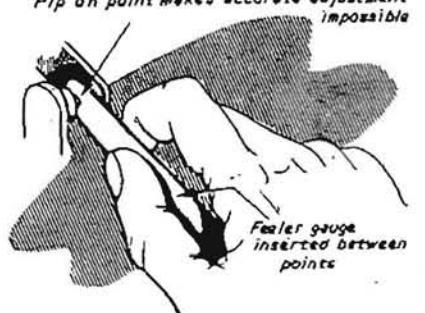
"Pip" on point makes accurate adjustment

Fig. 4. — A "pip" formation on the points makes it impossible to obtain an accurate gap setting.

When checking the contact breaker gaps it is of the utmost importance to make certain that there are no "pips" present on the working surface of the points. If there are such "pips" present, it will, of course, be impossible to obtain an accurate setting, for the protuberance will ride over the feeler gauge and result in a larger gap setting (Fig. 4). When the points are in this condition the contact breaker assembly should

be removed from the distributor body and the points refaced on a fine carborundum or oil stone, holding them absolutely parallel to the face of the stone and working gently in a rotary motion. The points are then cleaned of any abrasive matter with a petrol dampened cloth and held close together to ensure that both points meet fair and square. When replacing the contact breaker assembly care should be taken to see that the small fibre insulating washer is in position on the pivot pin (Fig. 5), otherwise a short circuit will occur and so put the ignition out of action.

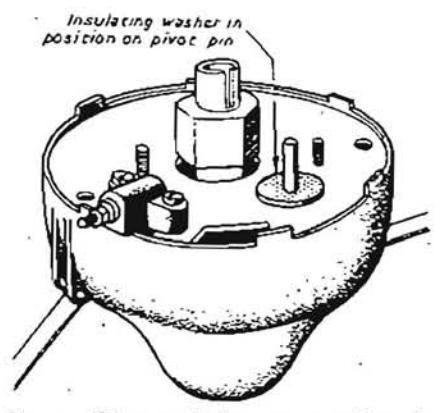
Fig. 5.—When replacing or renewing the contact breaker assembly, the insulating washer must be first into position on the pivot pin.

If the points are worn down to any extent by repeated refacing, it will, of course, be necessary to fit a replacement contact set. Very often these are covered with a fine film of light oil to protect the parts from the effects of the atmosphere, and before assembling this should be removed with a cloth dampened in petrol. Also supplied with the replacement sets is a fibre insulating washer which is intended to renew the old one from the pivot pin. When renewing the contact set apply a thin smear of petroleum jelly around the pivot pin and on the lobes of the cam and set the gap to the recommended clearance. This should be rechecked after soo miles to allow for the

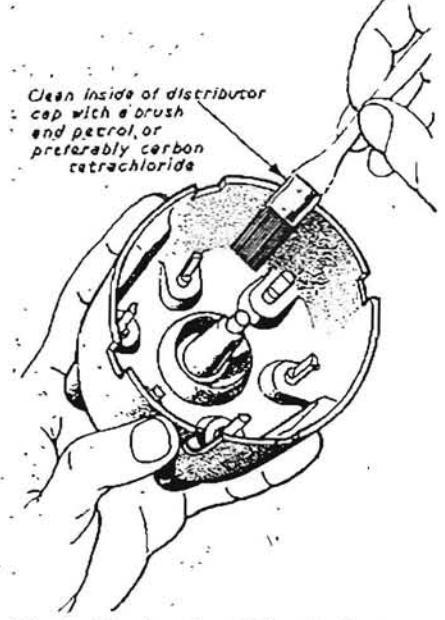
Fig. 6.-The laterior of the distributor cap is effectively cleansed with a brosh (see text).

It is a good plan to remove the distributor cap periodically, say, every 5,000 miles or so, and to clean out the interior thoroughly with a soit brush and petrol, or preferably carbon tetrachloride (Fig. 6). With petrol, there tetrachloride (Fig. 6). With petrol, there may be left a slight oily residue when dry, which will attract further dust, and if pos-sible, the latter fluid should be used. This is available as a dry cleaning fluid under various proprietary names, and is obtainable at most stores, etc. A brush is preferable for cleaning to a cloth, as it is possible to reach more thoroughly around each electrode. Clean the interior of the cap thoroughly with the fluid, wipe the surplus away with a clean rag, then leave for a few minutes to dry our before assembling.

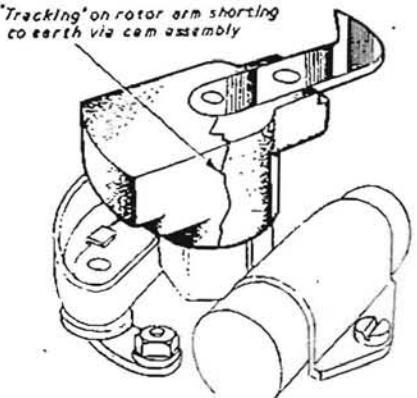
Fig. 7.-" Tracking" on the rotor arm puts the entire H.T. system out of action.

The rotor arm should be removed at the same nime as the cap and similarly cleaned. The rotor arm is particularly susceptible to shorting or "tracking" due to fine carbon dust being deposited from the small brush with which it makes contact. This "track-ing" dead shorts to earth via the cam assembly (Fig. 7), and when this occurs the H.T. ignition system completely fails. In

this eventuality, the rotor arm must be replaced.
