Sidescreen Restoration

The sidescreens on my TF had long ago become quite dangerous to drive with as the original acetate glazing had become so opaque that it was difficult to see other vehicles at road junctions etc.

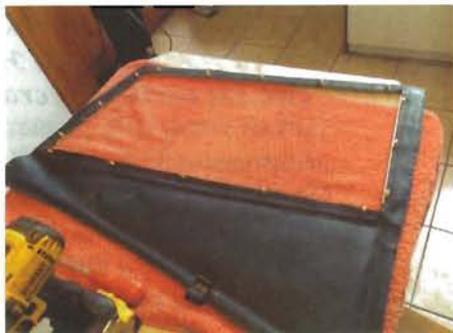
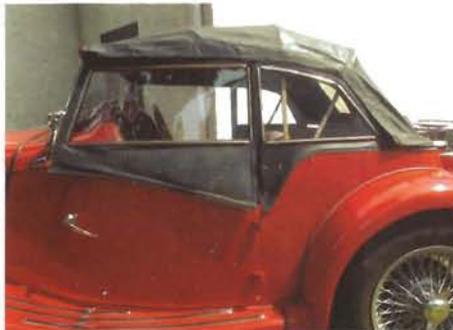
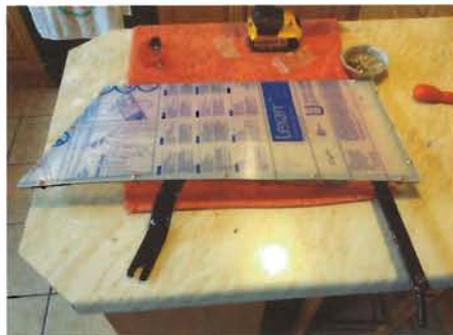
I have to say that the finished job is a huge improvement. The visibility is excellent and I no longer pull out in front

Firstly I dismantled the sidescreen assembly, carefully separating the steel frame from the vinyl trim, and cutting away the old glazing material. The steel frames were also cleaned up and repainted at this point

I purchased a sheet of clear 1 mm Lexan polycarbonate which, once the protective layer is peeled off, is as clear as glass.

Using the frame as a template I cut the polycarbonate with good large scissors and having clamped it to the frame, drilled it to take the fixing bolts.

Here I used 2BA round head brass bolts and nuts. The round head fits snugly into the 4 chrome trim strips and thus allows the frame, polycarbonate and vinyl trim to be re-assembled neatly.
